MUAYENE VE DENEY RAPORU
TEST REPORT

Numunenin Tanımı : 2025-366570, Double leaves fire door, -, -, -, -, 1.00, adet
(Cins, Marka, Sınıf, Tip, Tür, Model vb.)
Sample Description (Type, Mark, Class, Model etc.)

Uygulanan Standart Metot : TS EN 1634-1+A1/TS EN 1634-1+A1 Kapı ve kepenk takımları, bina hırdavatının
Applied Standard/Method açılabilir pencereleri ve elemanları için yangına dayanıklılık ve duman kontrol deneyleri - Bölüm 1: Kapı ve kepenk takımları ve açılabilir pencereler için yangına dayanıklılık deneyi

Single acting (opening away from the furnace) double leaves metal door set with metal frame test sample with " description sponsored by "YELKEN KALIP PENCERE-KAPI AKS.VE METAL SAN.TİC.A.Ş." was tested at 02 January 2026 at TSE Construction Materials Fire and Acoustics Laboratory according to TS EN 1634-1+A1:2018.

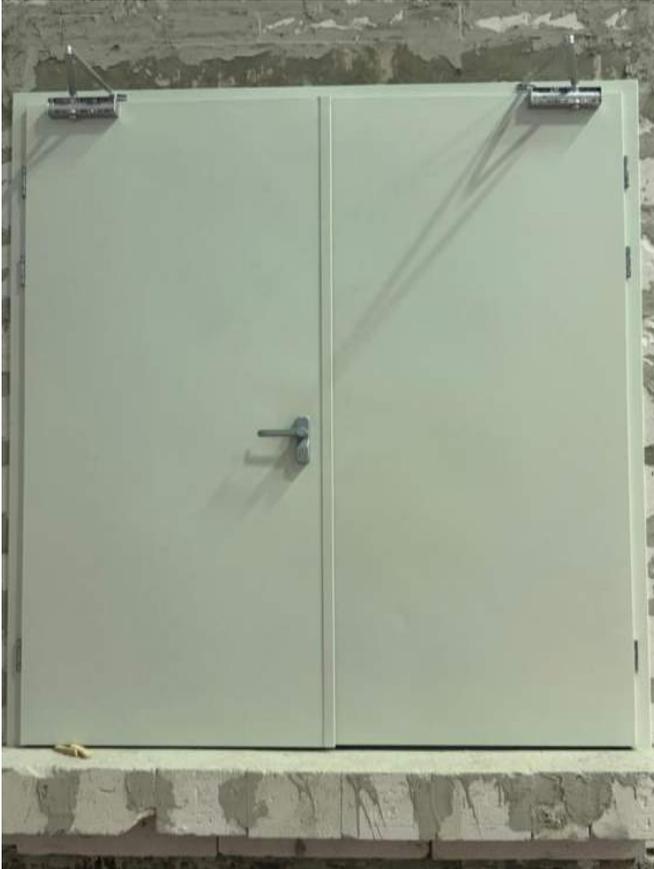
Unexposed face before test

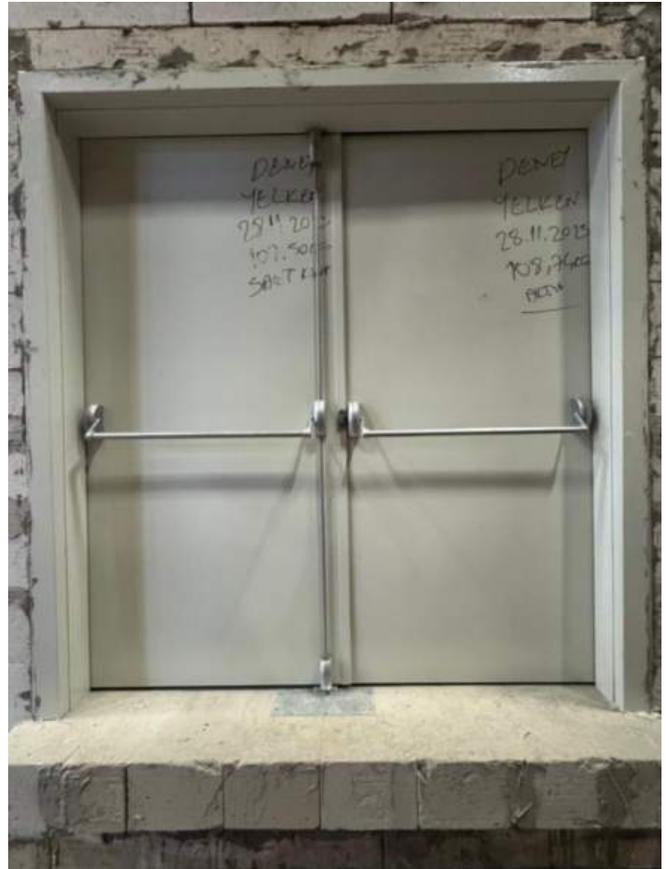
Exposed face before test

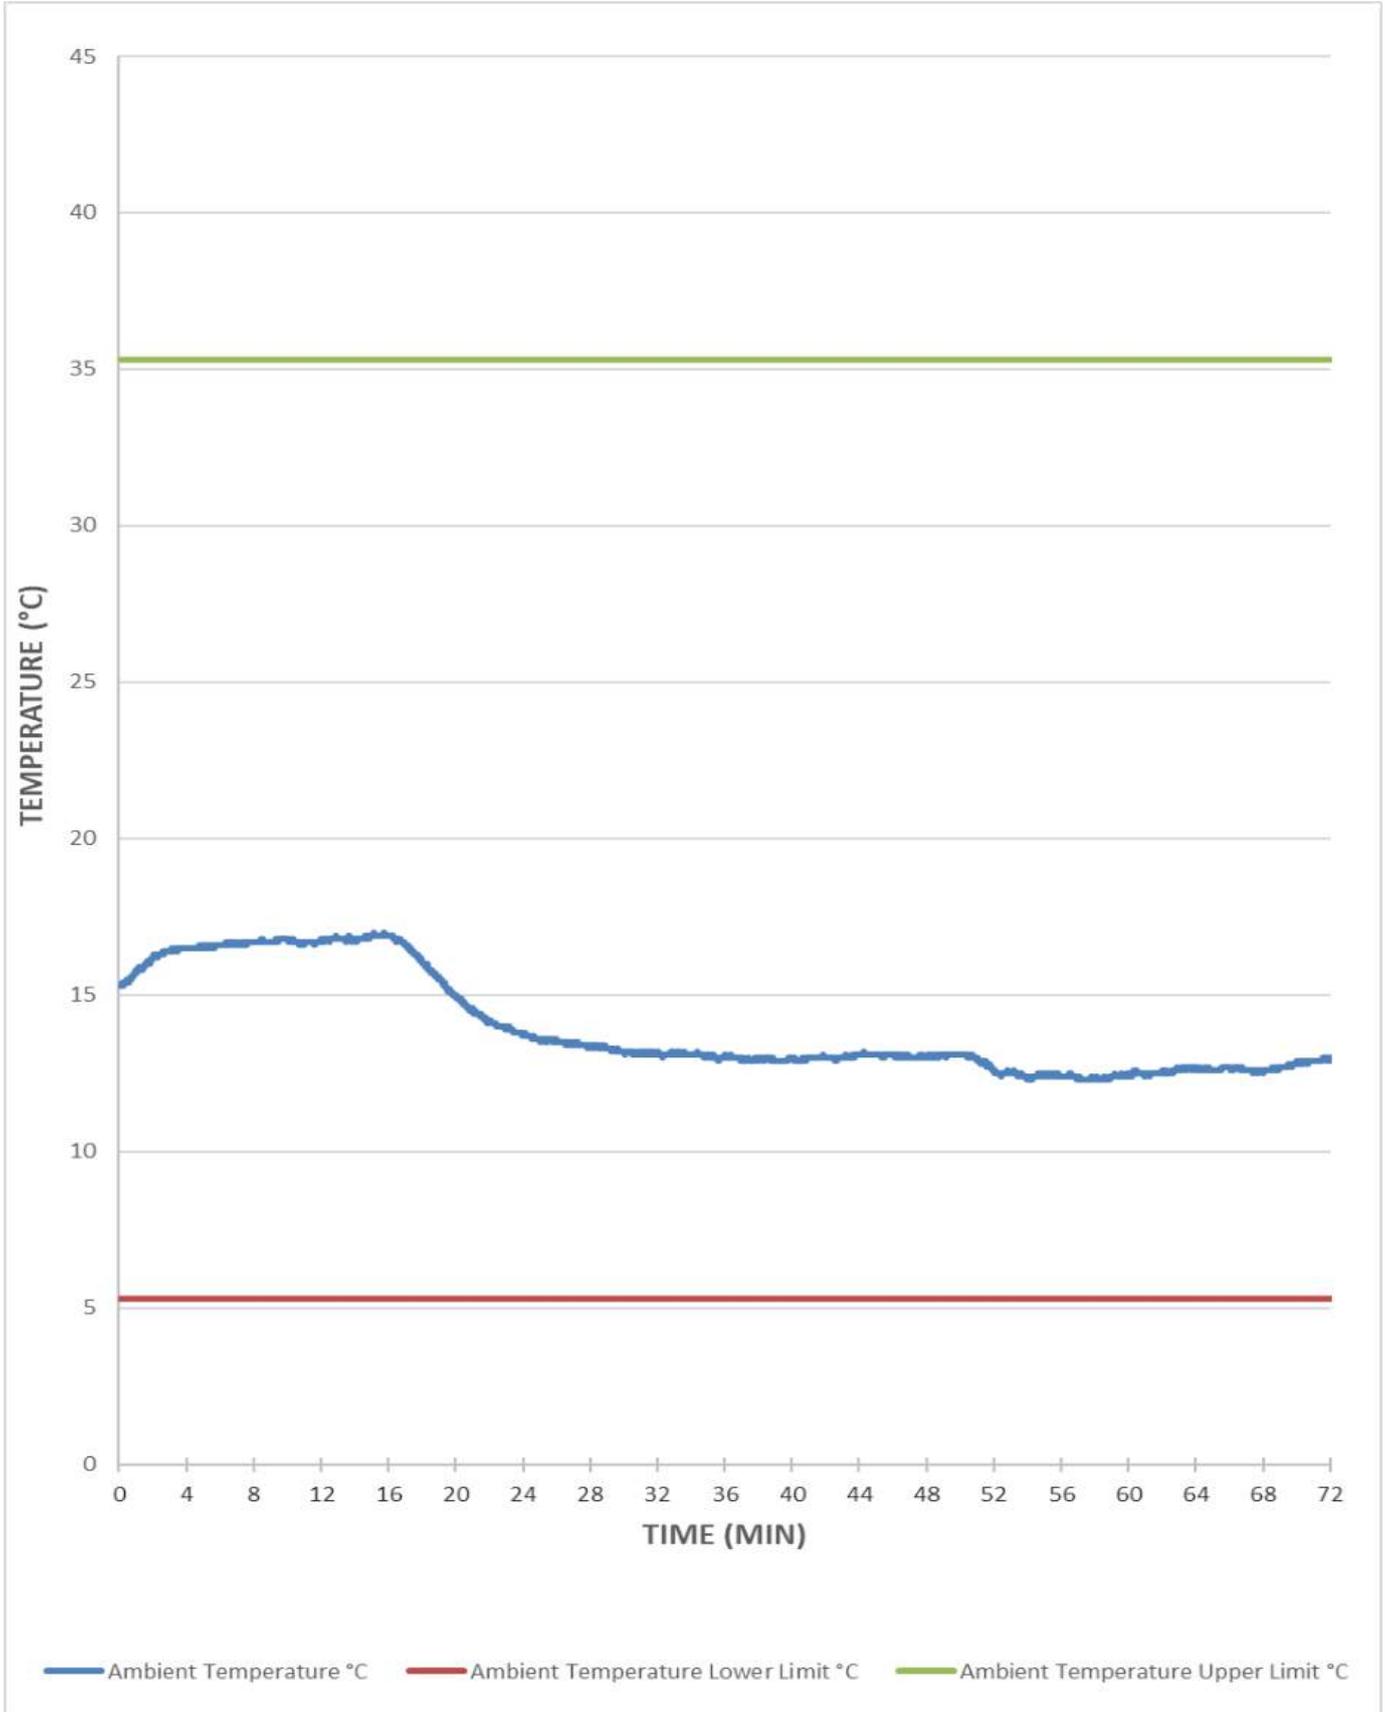
Figure 6.1. Ambient Temperature Graphic

Temperature: 15,3 °C and Humidity: 22,9% RH were measured before the test.Ambient temperature-time graphic is given in the Figure 6.1.

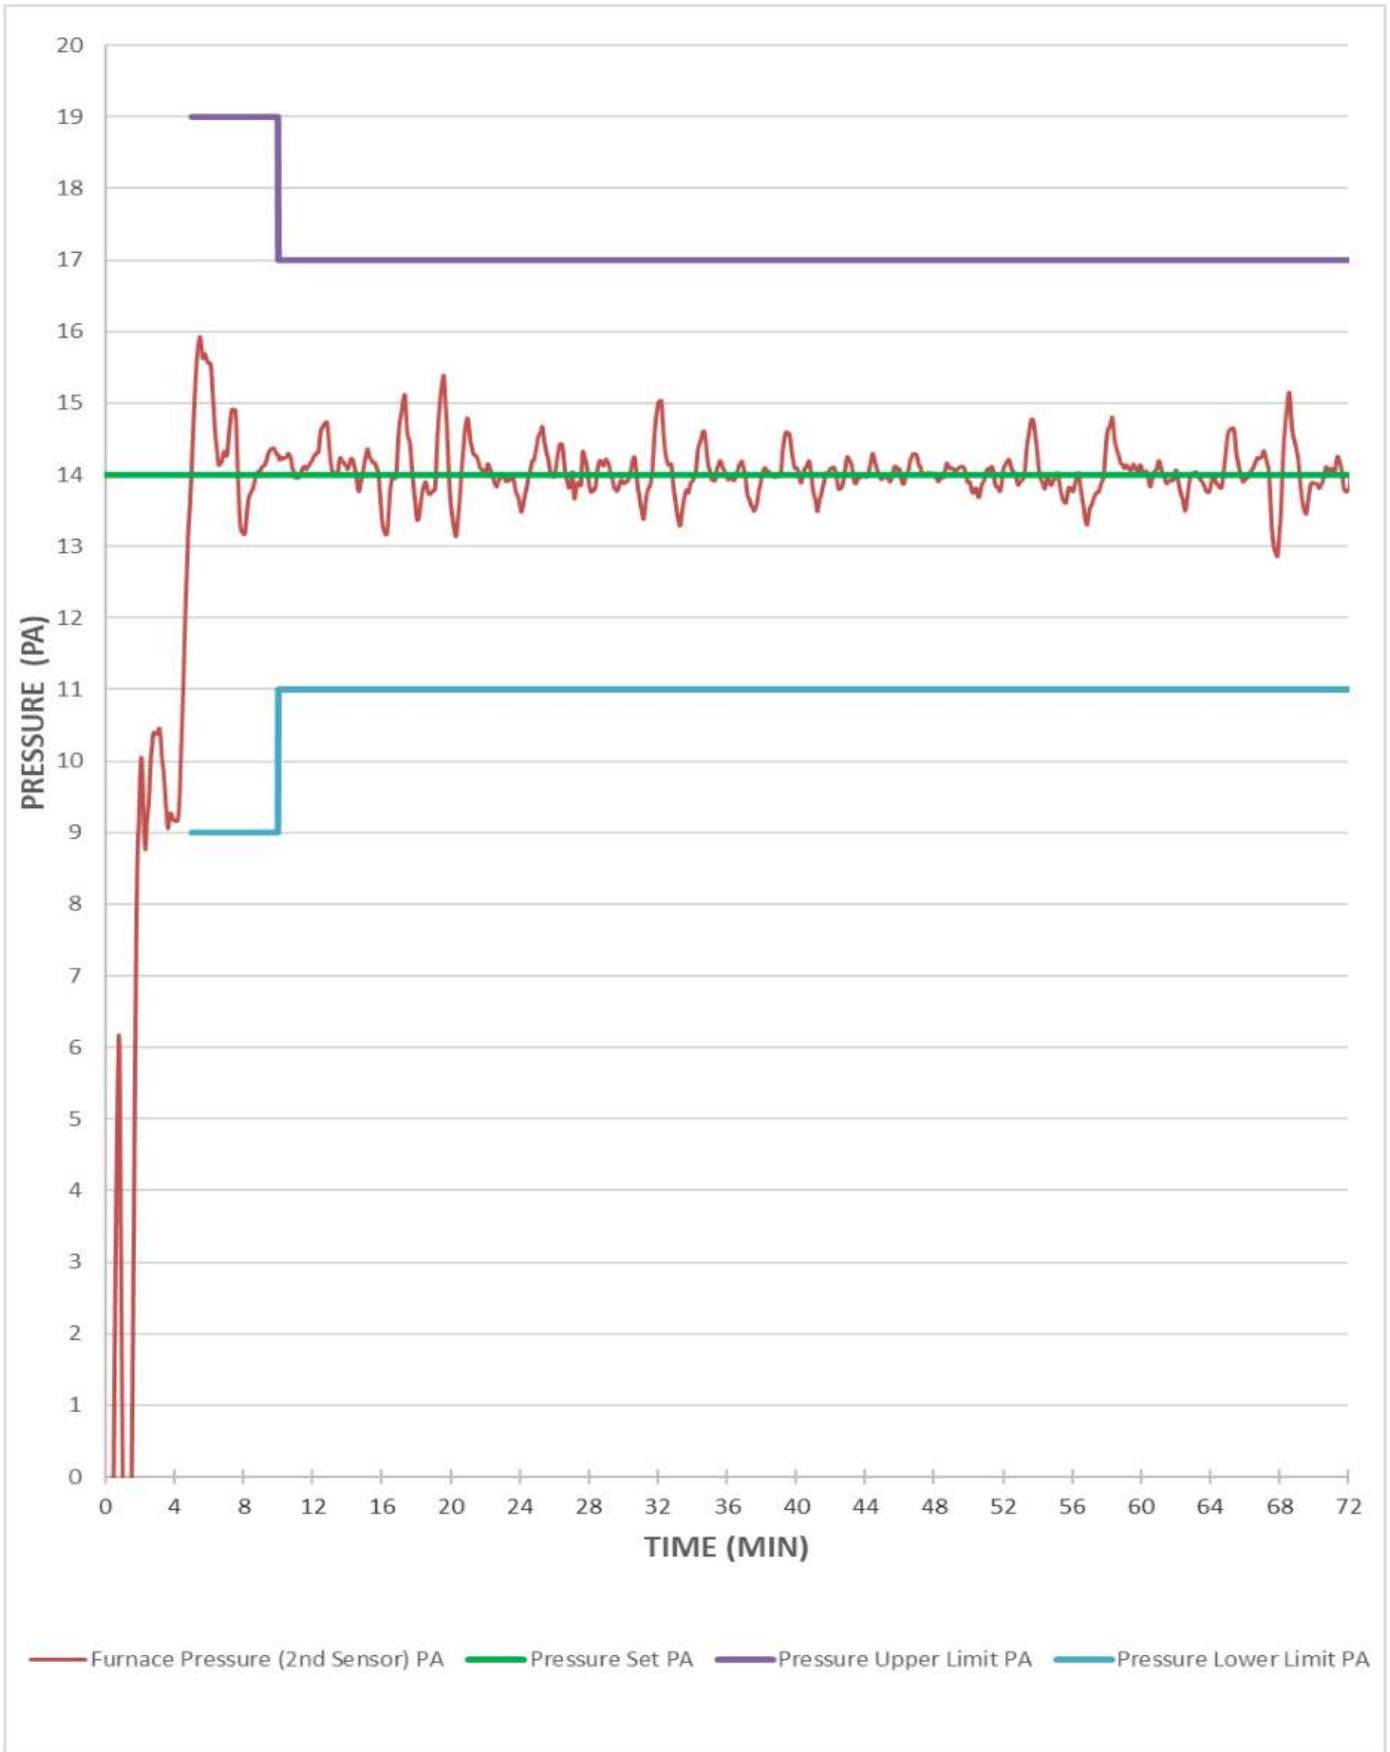
Figure 6.2. Furnace internal pressure graphic

Furnace internal pressure is controlled according to TS EN 1363-1: 2020 Clause 5.2. Furnace pressure shall not be more than 20 Pa at the top edge of the sample. Horizontal flat surface (notional floor level) was erected 300 mm above the furnace floor for simulating the continuity of the floor specified by the standard. In order to provide 0,00 Pa pressure at 0,5 m height from notional floor level, furnace pressure in the second pressure sensor (Located at 2,45 m) was adjusted to 14 Pa. Furnace pressure-time graphic is given in the Figure 6.2.

All values are in limit.

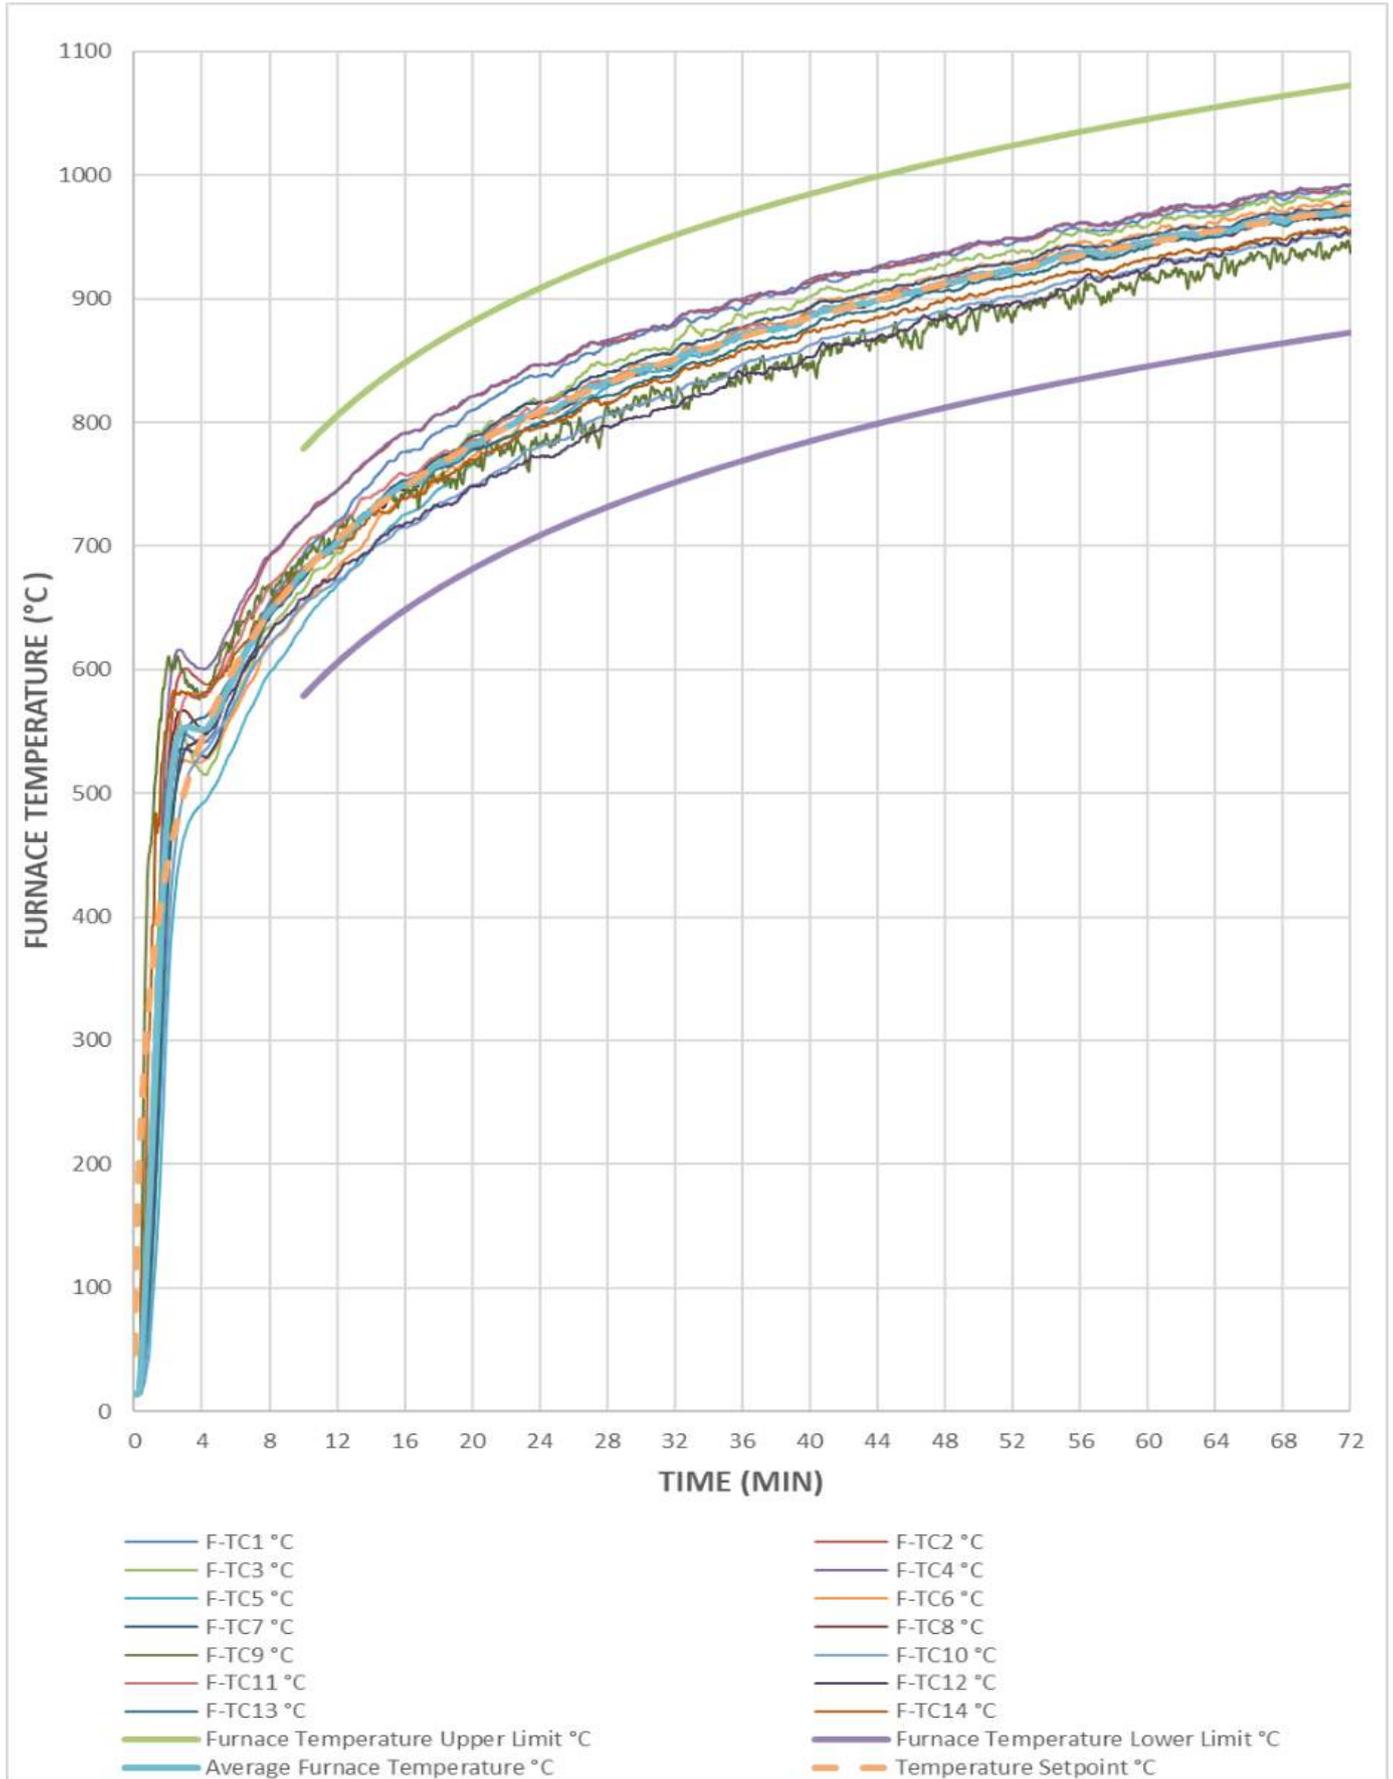
Figure 6.3. Furnace internal temperature graphic

Furnace internal temperature values, upper and lower limits specified in TS EN 1363-1: 2020 are given in the Figure 6.3.

After first 10 minutes, no values at any time deviated more than 100°C as described in time temperature curve.

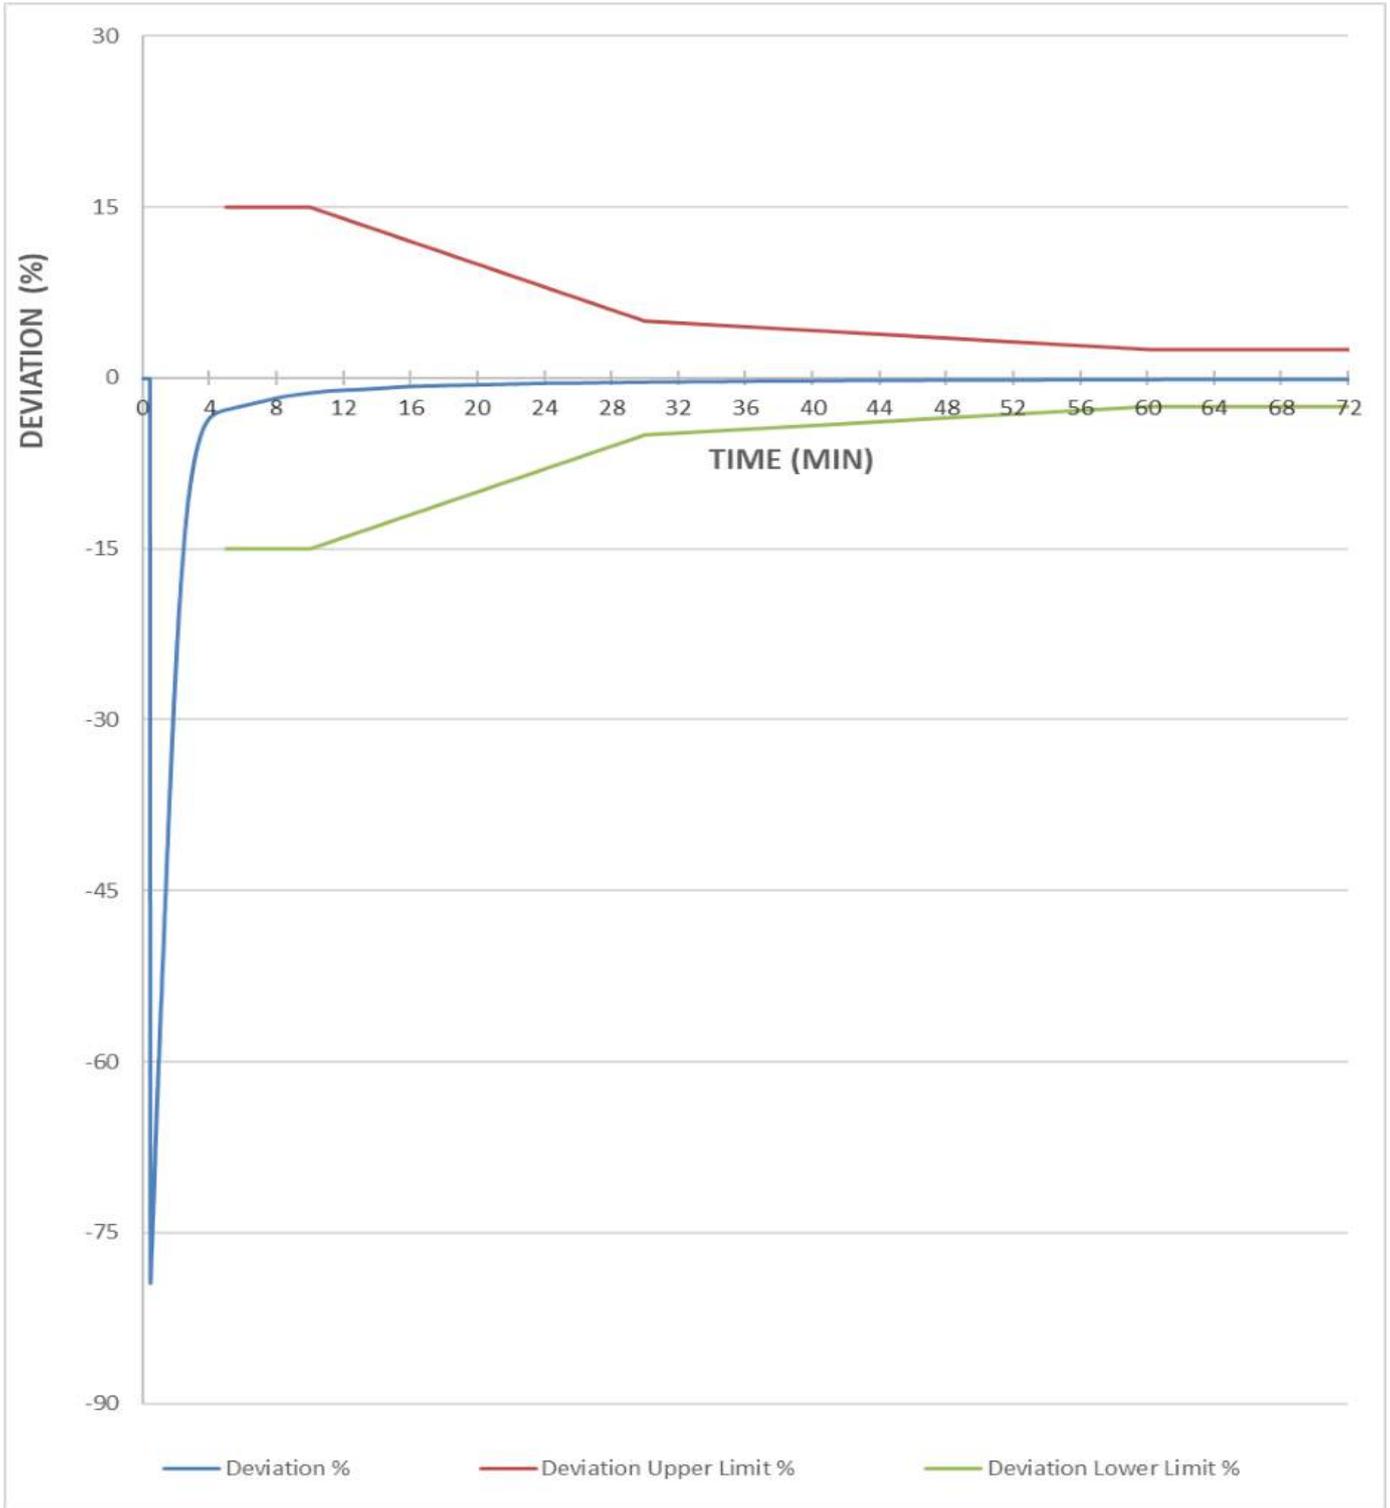
Figure 6.4. Deviation-time graphic

The percentage deviation (d_e) in the area of the curve of the average temperature recorded by the specified furnace thermocouples versus time from the area of the standard temperature/time curve shall be within:

- for $5 < t \leq 10$, % 15
- for $10 < t \leq 30$, $(15 - ((0,5(t-10)))$ %
- for $30 < t \leq 60$, $(5 - 0,083 (t - 30))$ %
- for $t > 60$, 2,5 %

$$d_e = (A - A_s) / A_s \times 100$$

Deviation-time graphic is given in the Figure 6.4.

All values after 5 minutes are in limit.

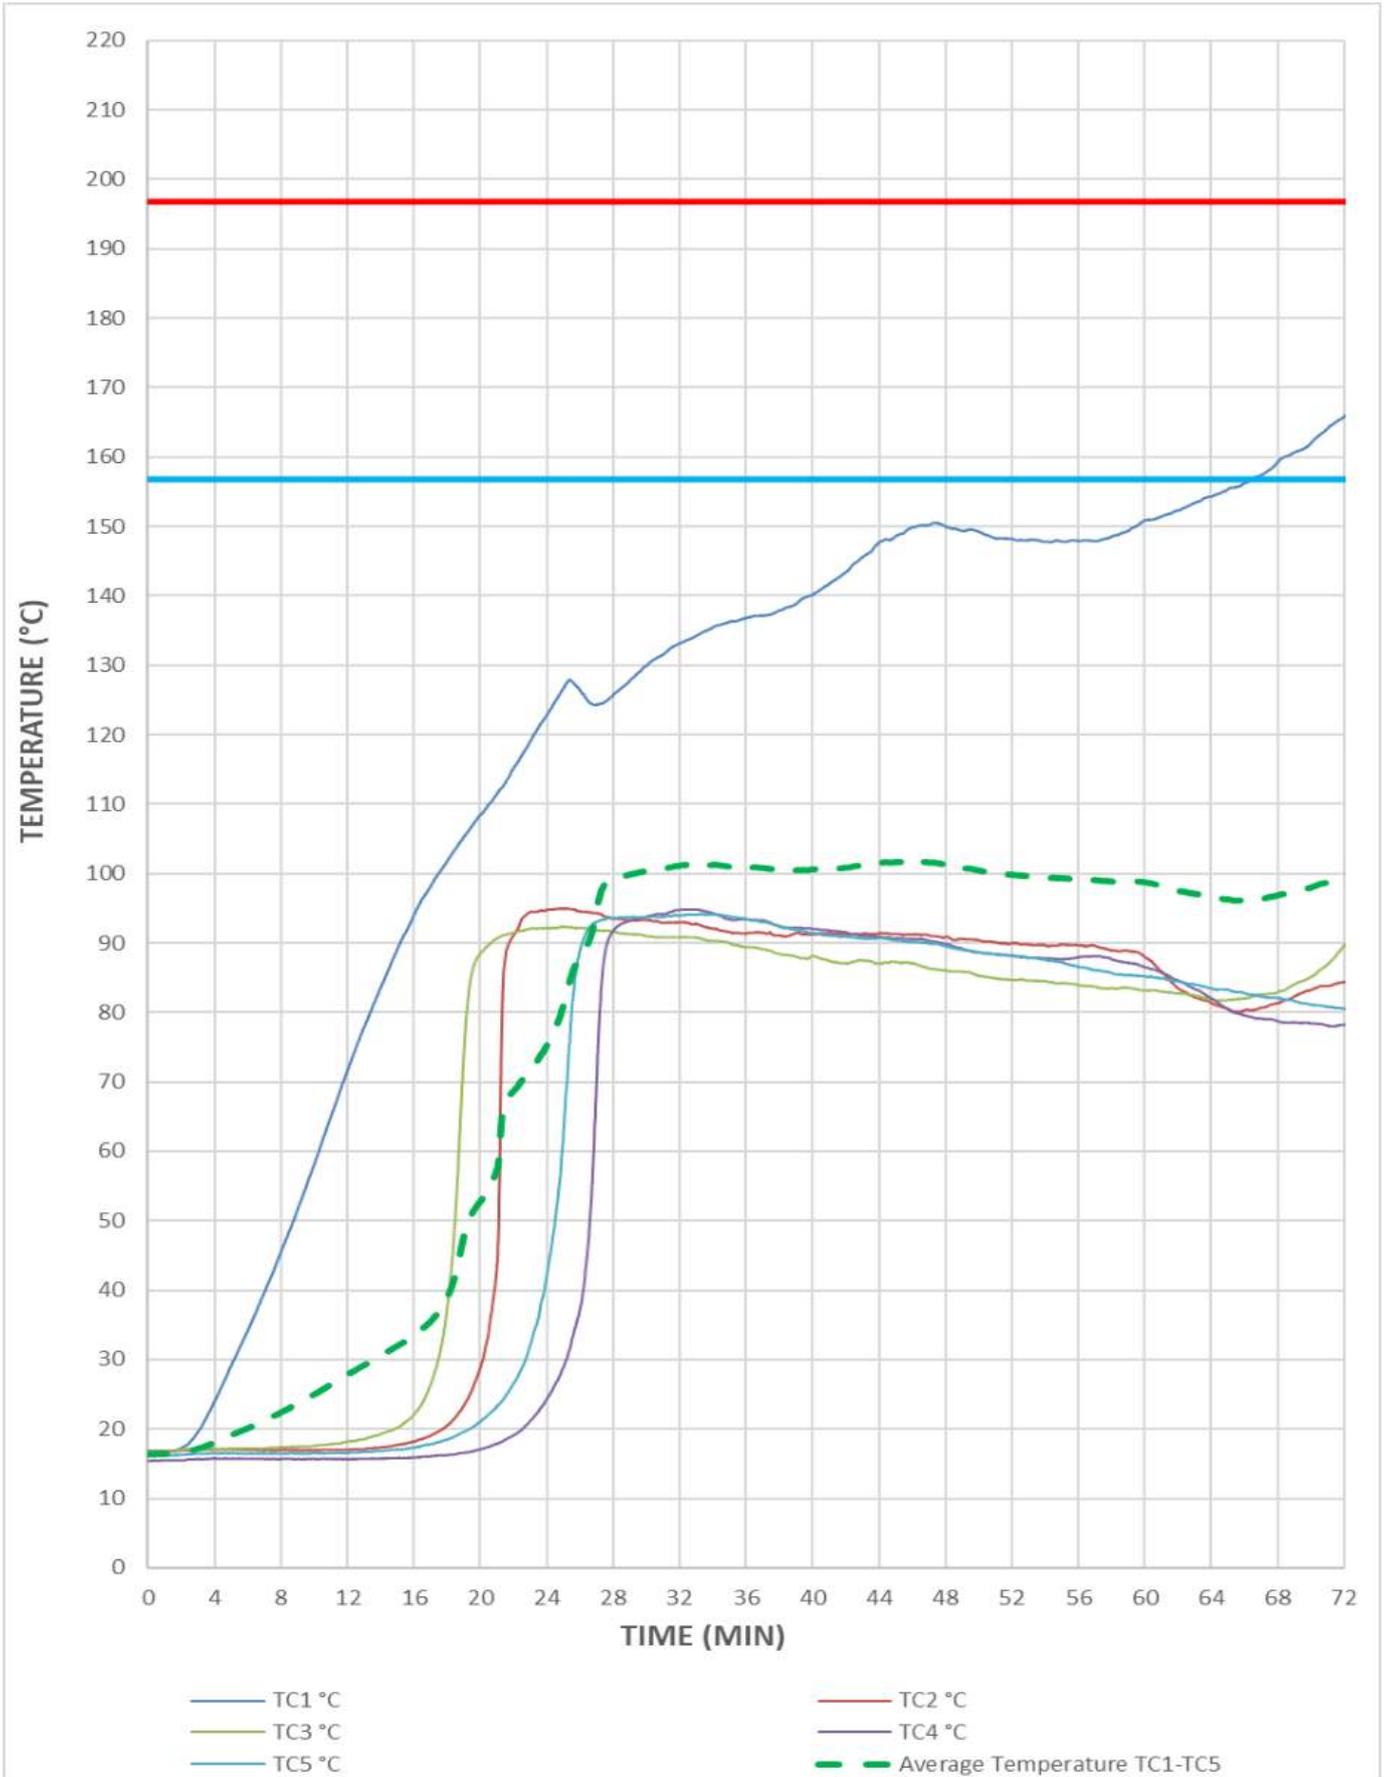
Figure 6.5. Temperatures of average and maximum unexposed face (Leaf) thermocouples (TC)

18 thermocouples were attached to the unexposed surface of the sample with insulating pads, and the first 5 thermocouples (thermocouples between TC1 and TC5) were used to measure the average temperature of the sample surface. In the surface measurement values, the average surface temperature value (initial temperature) calculated from the average temperature measurement thermocouples shall not increase more than 140°C. For any of the leaf/leaves thermocouple temperatures between TC1–TC13 for the maximum temperature value, the maximum increase value shall not be more than 180°C from the initial temperature. Also, for any of the frame thermocouple temperatures between TC14–TC18 for the maximum temperature value, the maximum increase value shall not be more than 360°C from the initial temperature.

The initial temperature value (calculated by taking the average temperature of the thermocouples on the unexposed face before the test) is 16,76 °C.

The time-dependent thermocouple temperatures are given in the Figure 6.5, Figure 6.6 and Figure 6.7.

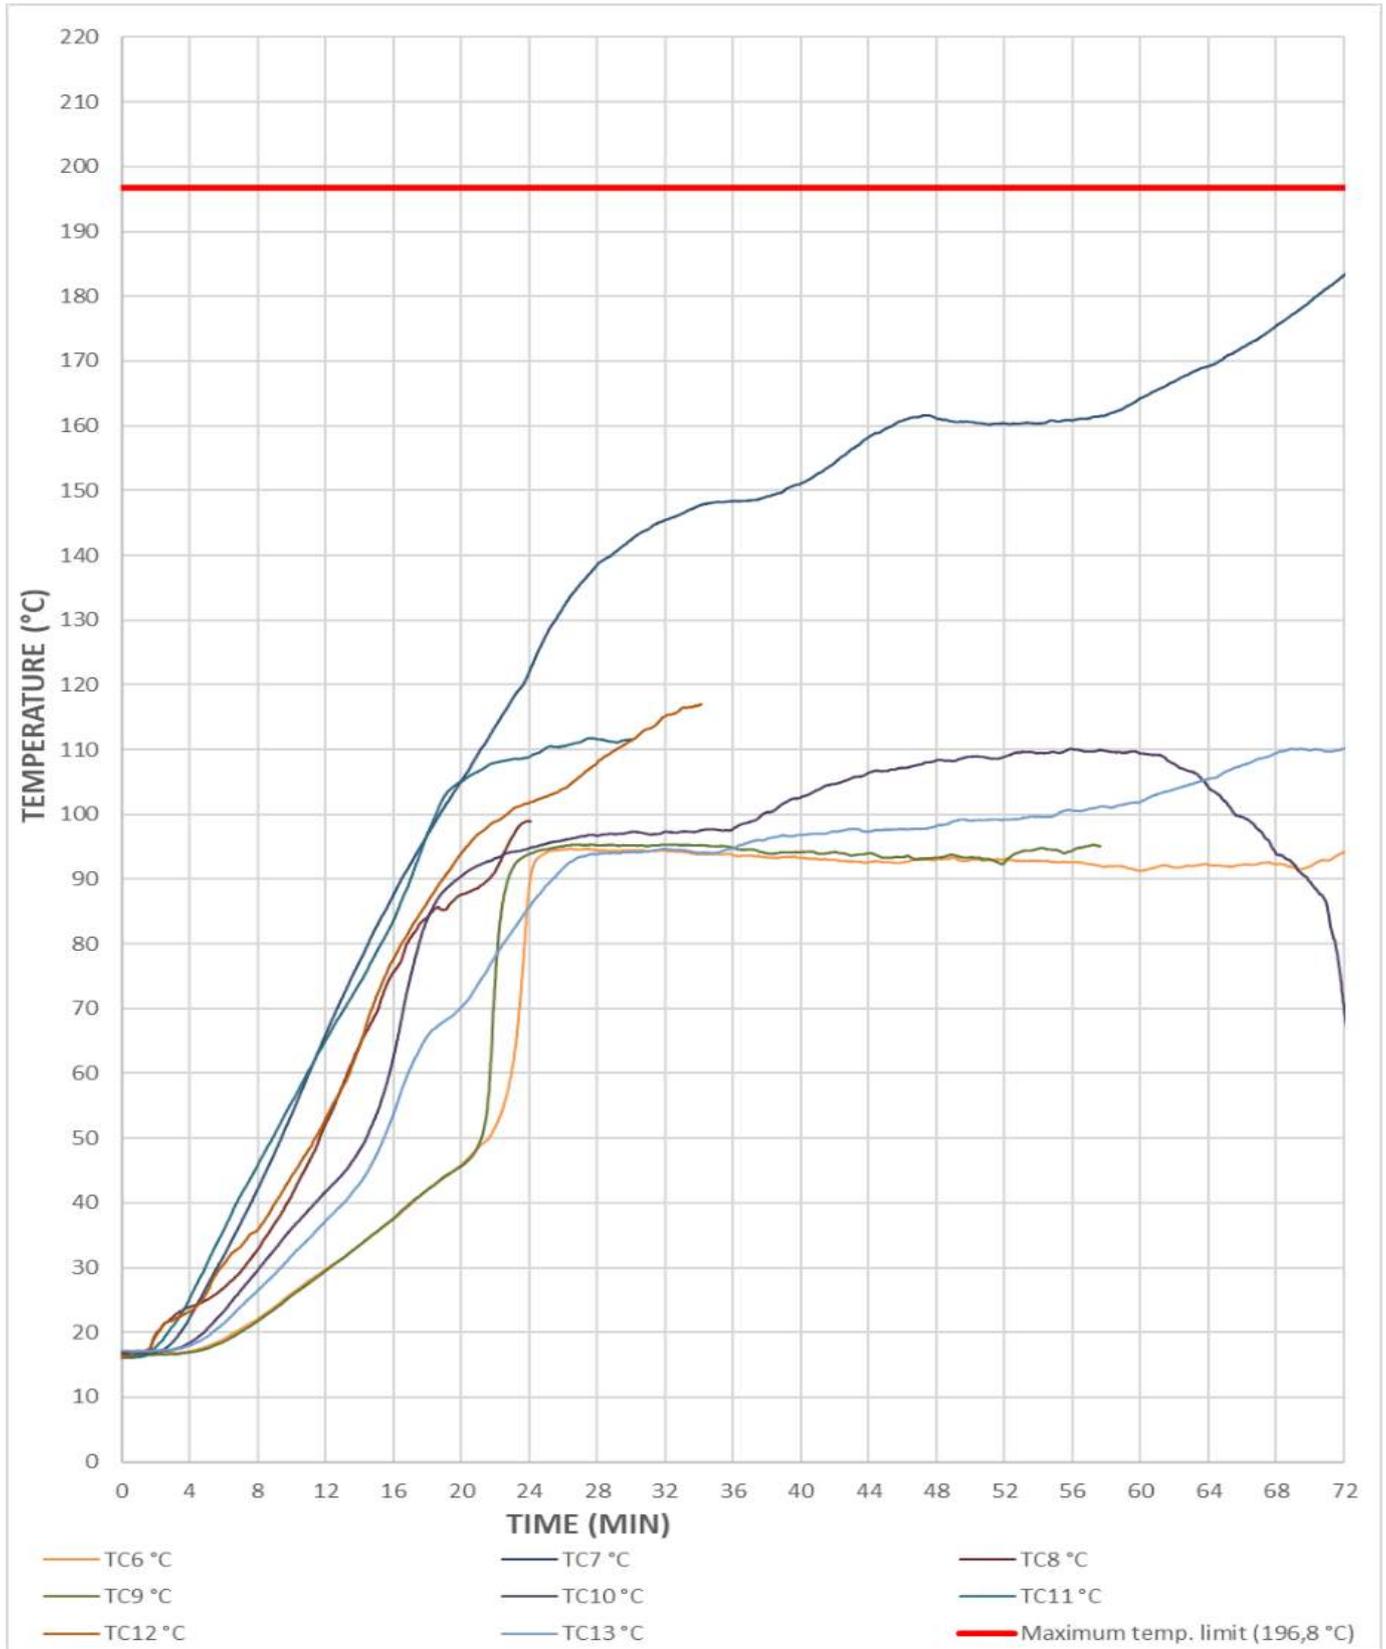
Figure 6.6. Temperatures of maximum unexposed face (leaf) thermocouples (TC)

Note: Thermocouple number 8 detached and fell from the sample at 24 minutes and 7 seconds, thermocouple number 9 at 57 minutes and 38 seconds, thermocouple number 11 at 30 minutes and 2 seconds, and thermocouple number 12 at 24 minutes and 9 seconds.

Note: The thermocouple number 8 fell down from the sample at 24 minutes and 7 seconds, thermocouple numbers 9, fell down from the sample at 57 minutes and 38 seconds, thermocouple number 11 fell down from the sample at 30 minutes and 2 seconds, thermocouple number 12 fell down from the sample at 34 minutes and 9 seconds, thermocouple number 14 fell down from the sample at 29 minutes and 48 seconds, thermocouple number 15 fell down from the sample at 17 minutes and 42 seconds, thermocouple number 17 fell down from the sample at 19 minutes and 49 seconds.

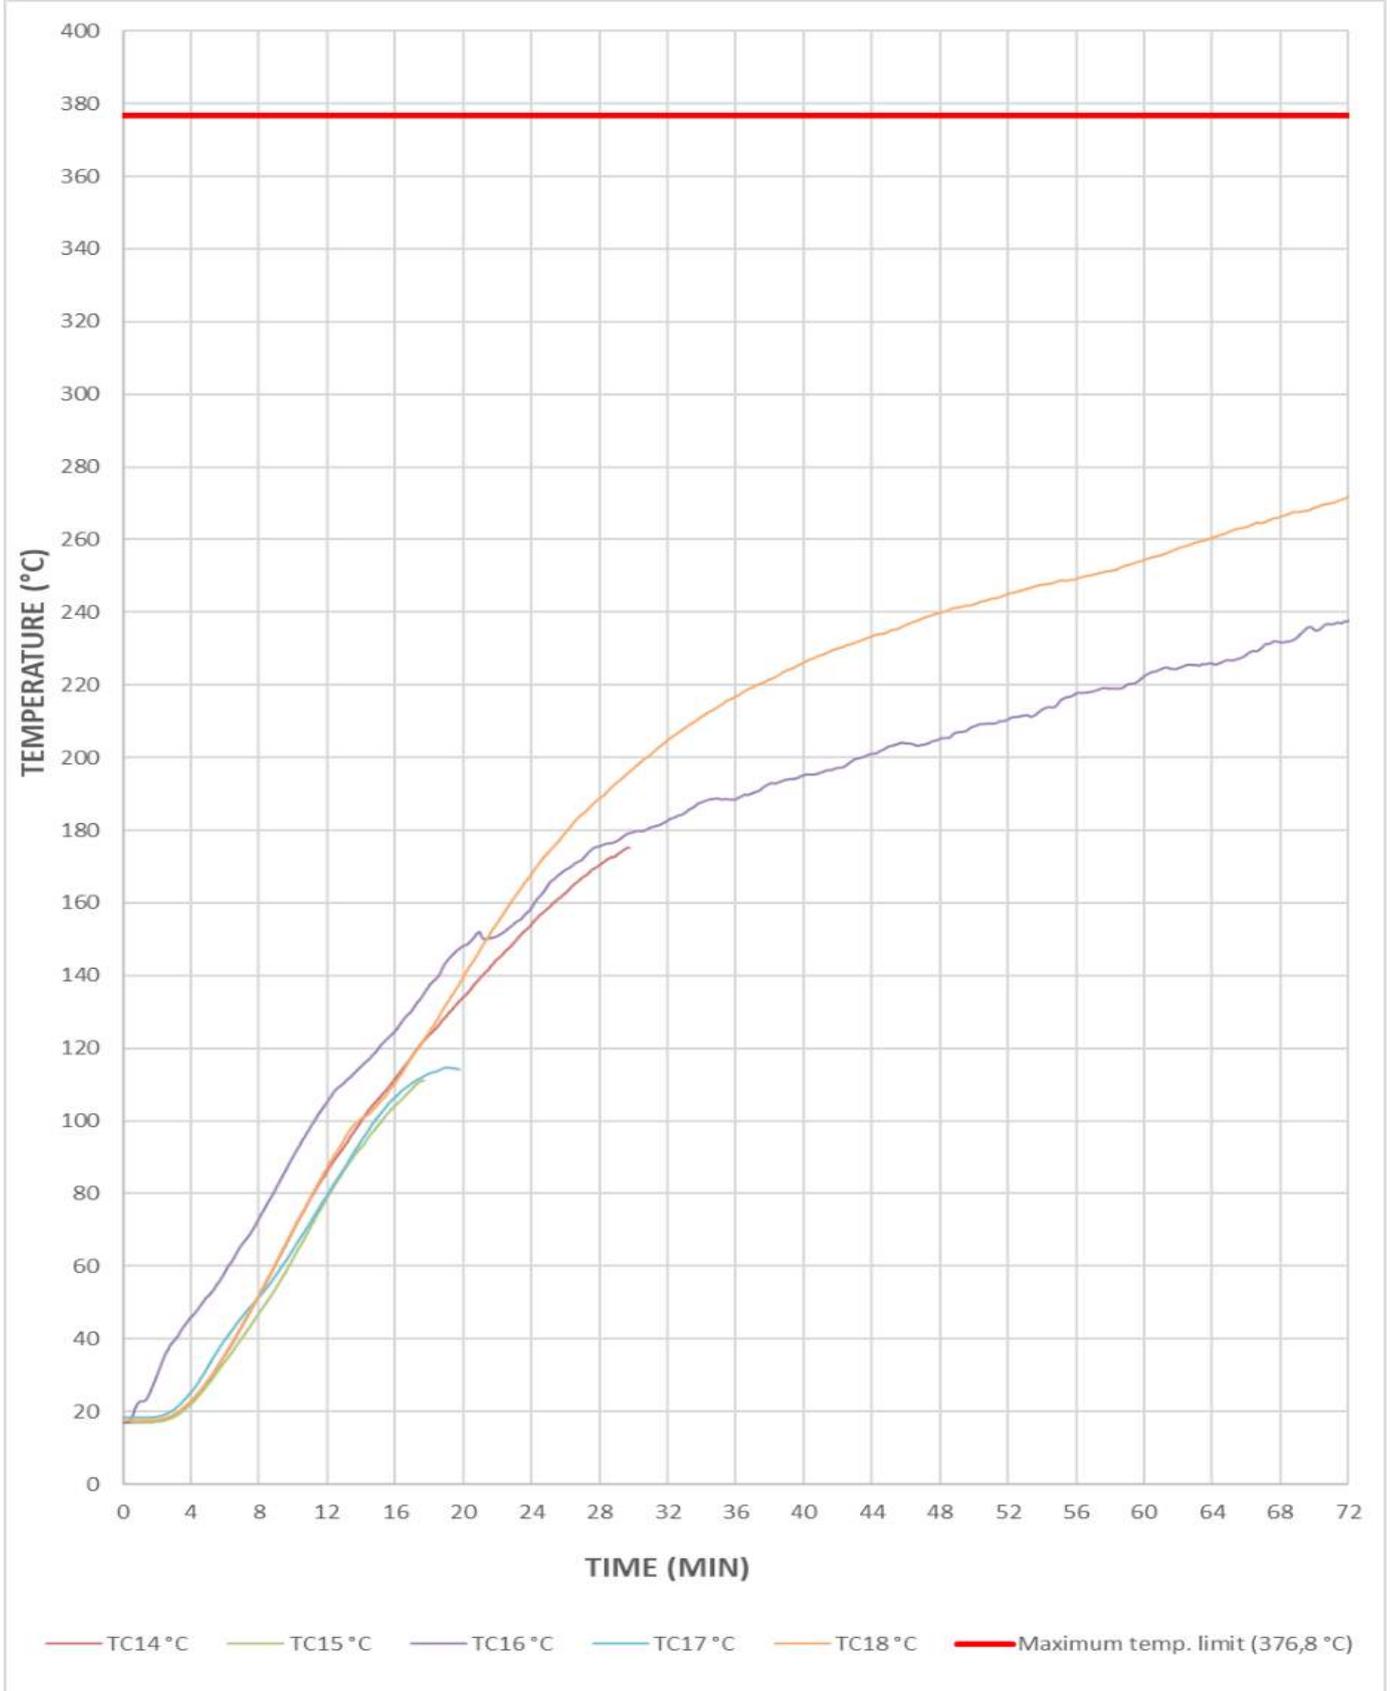
Figure 6.7. Temperatures of maximum unexposed face (frame) thermocouples (TC)

Note: Thermocouple 14 detached and fell from the anatomical specimen at 29 minutes and 48 seconds, thermocouple 15 detached and fell at 17 minutes and 42 seconds, and thermocouple 17 detached and fell at 19 minutes and 49 seconds.

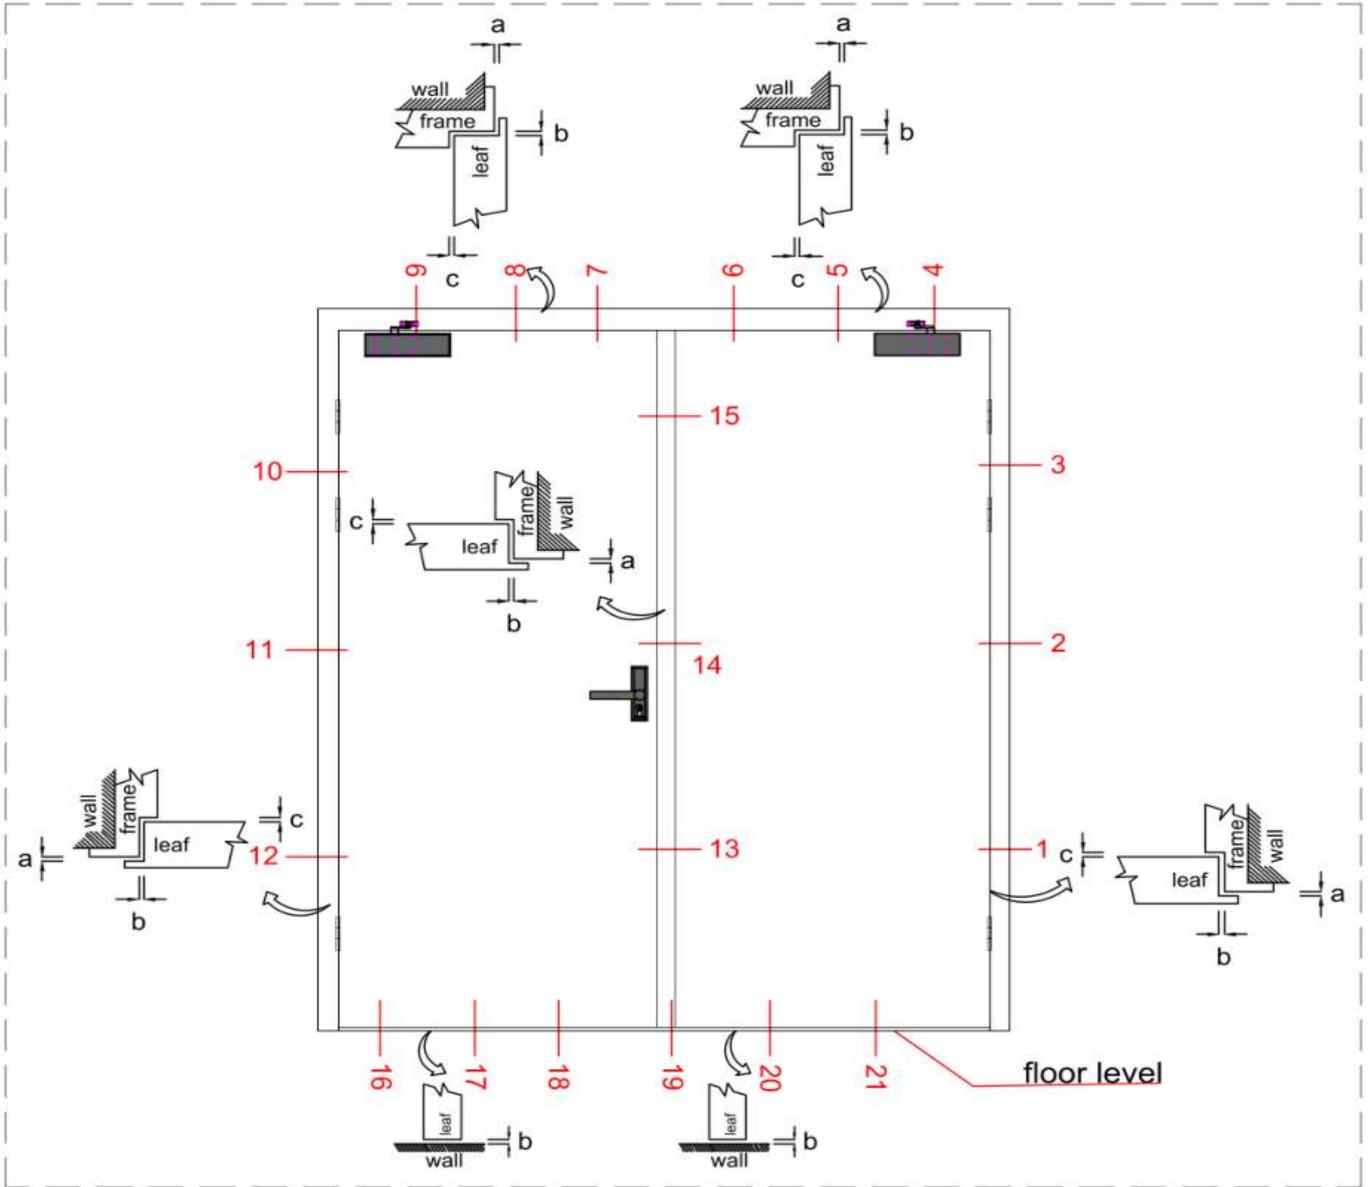
Figure 7.1. Gap measurement points and the gaps for each measurement section (Unexposed face view)

Gap measurement locations and each measured section detail for gaps between the frame and the leaf and between the two leaves in the closed position from unexposed face are given in the Figure 7.1.

a	b*	c
1	0,60	4,30	0,10
2	0,30	4,60	0,10
3	0,60	5,50	0,10
4	0,20	4,40	0,10
5	0,60	3,50	0,15
6	2,20	3,00	0,25
7	6,90	6,50	0,80
8	5,50	6,45	0,70
9	2,80	5,70	0,60
10	0,35	7,50	0,05
11	0,40	6,45	0,05
12	0,75	4,90	0,05
13	1,15	6,90	0,75
14	1,25	6,30	0,60
15	2,10	6,30	0,65
16	-	1,00	-
17	-	1,90	-
18	-	5,25	-
19	-	13,20	-
20	-	9,10	-
21	-	5,30	-

Measurement section	No	Mean Value (mm)	Maximum Value (mm)	Maximum Permitted Gap Size (mm)
Right leaf (passive leaf) hinged edge to frame	b_{1,2,3}	4,80	5,50	7,15
Right leaf (passive leaf) to frame head	b_{4,5,6}	3,63	4,40	6,02
Left leaf (active leaf) to frame head	b_{7,8,9}	6,22	6,50	8,36
Left leaf (active leaf) hinged edge to frame	b_{10,11,12}	6,28	7,50	8,89
Between the two leaves	b_{13,14,15}	6,50	6,90	8,70
Left (active) leaf bottom edge to sill	b_{16,17,18}	2,72	5,25	5,98
Right (passive) leaf bottom edge to sill	b_{19,20,21}	9,20	13,20	13,20

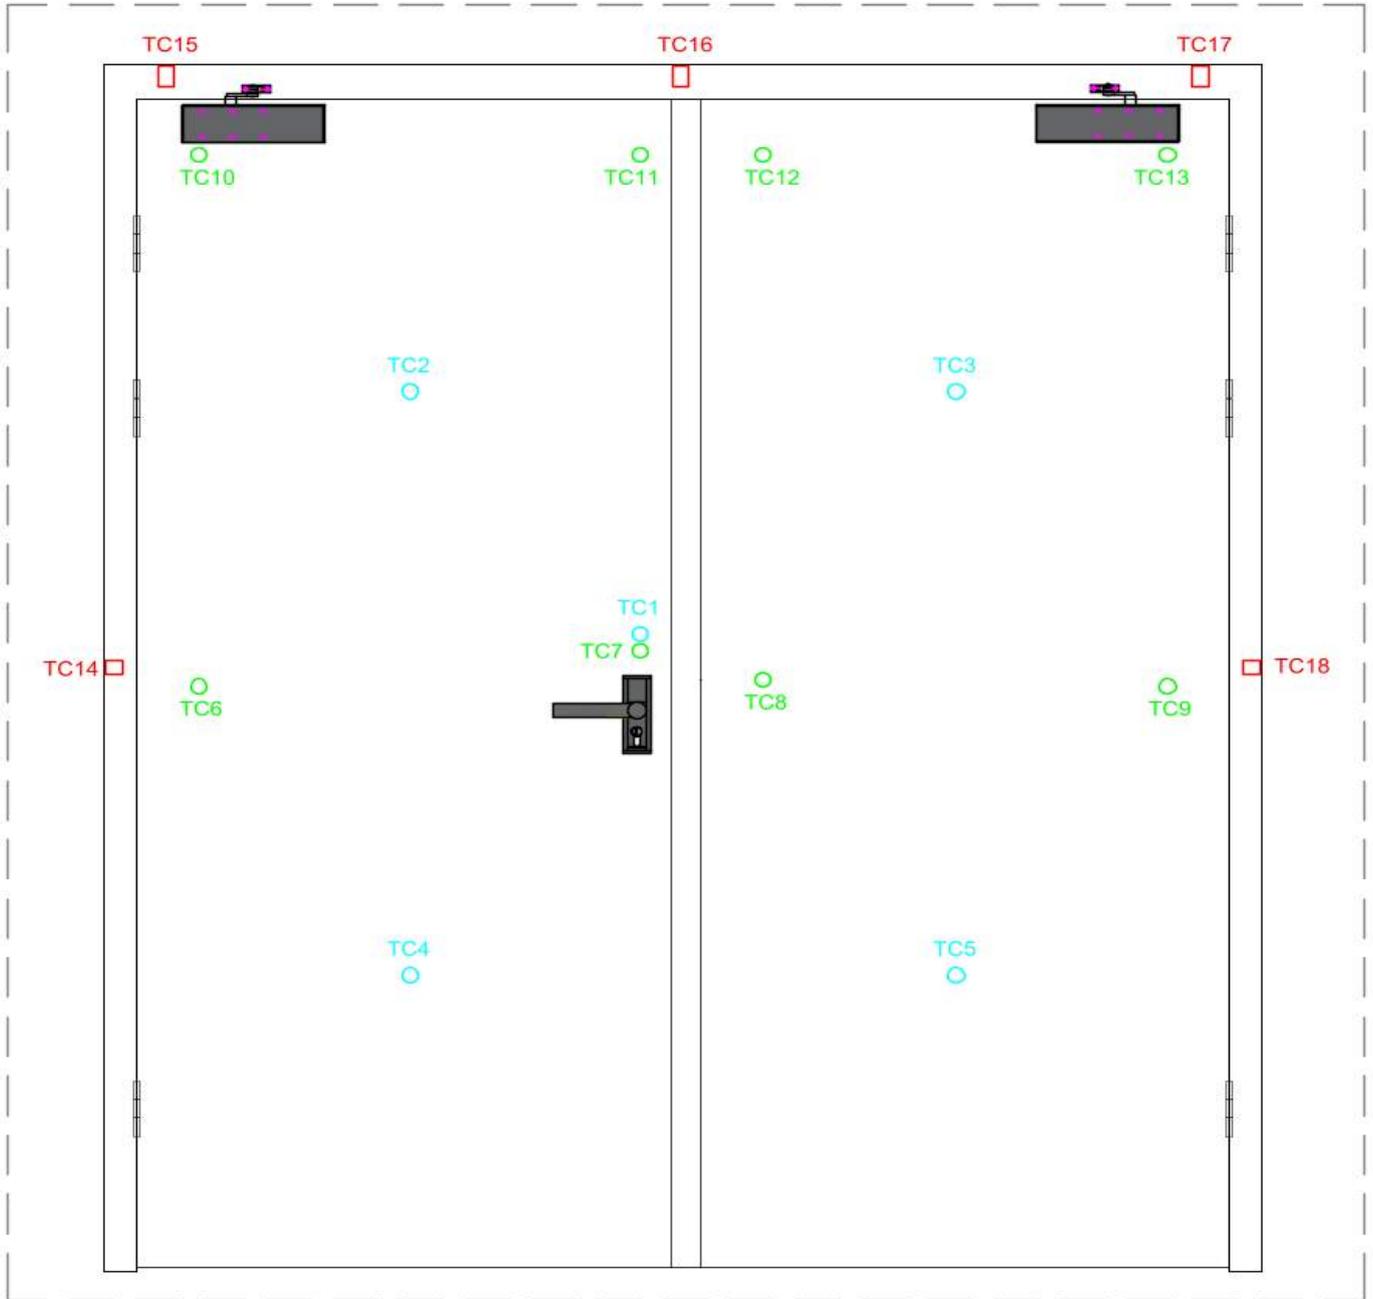
O: Leaf thermocouples (TC) (average and maximum temperature)

□: Frame Thermocouples (TC) (maximum temperature)

Figure 7.2. Unexposed face thermocouple measurement points

Unexposed face thermocouples and deflection measurement positions are given in the Figure 7.2 and Figure 7.3. The numbering in the figure is the same as the numbering of thermocouples. Time dependent displacement values are given in the table below.
