MUAYENE VE DENEY RAPORU
TEST REPORT

Numunenin Tanımı : 2025-366570, Double leaves fire door, -, -, -, -, 1.00, adet
(Cins, Marka, Sınıf, Tip, Tür, Model vb.)
Sample Description (Type, Mark, Class, Model etc.)

Uygulanan Standart Metot : TS EN 1634-1+A1/TS EN 1634-1+A1 Kapı ve kepenk takımları, bina hırdavatının
Applied Standard/Method açılabilir pencereleri ve elemanları için yangına dayanıklılık ve duman kontrol deneyleri - Bölüm 1: Kapı ve kepenk takımları ve açılabilir pencereler için yangına dayanıklılık deneyi

Single acting (opening away from the furnace) double leaves metal door set with metal frame test sample with " description sponsored by "YELKEN KALIP PENCERE-KAPI AKS.VE METAL SAN.TİC.A.Ş." was tested at 02 January 2026 at TSE Construction Materials Fire and Acoustics Laboratory according to TS EN 1634-1+A1:2018.

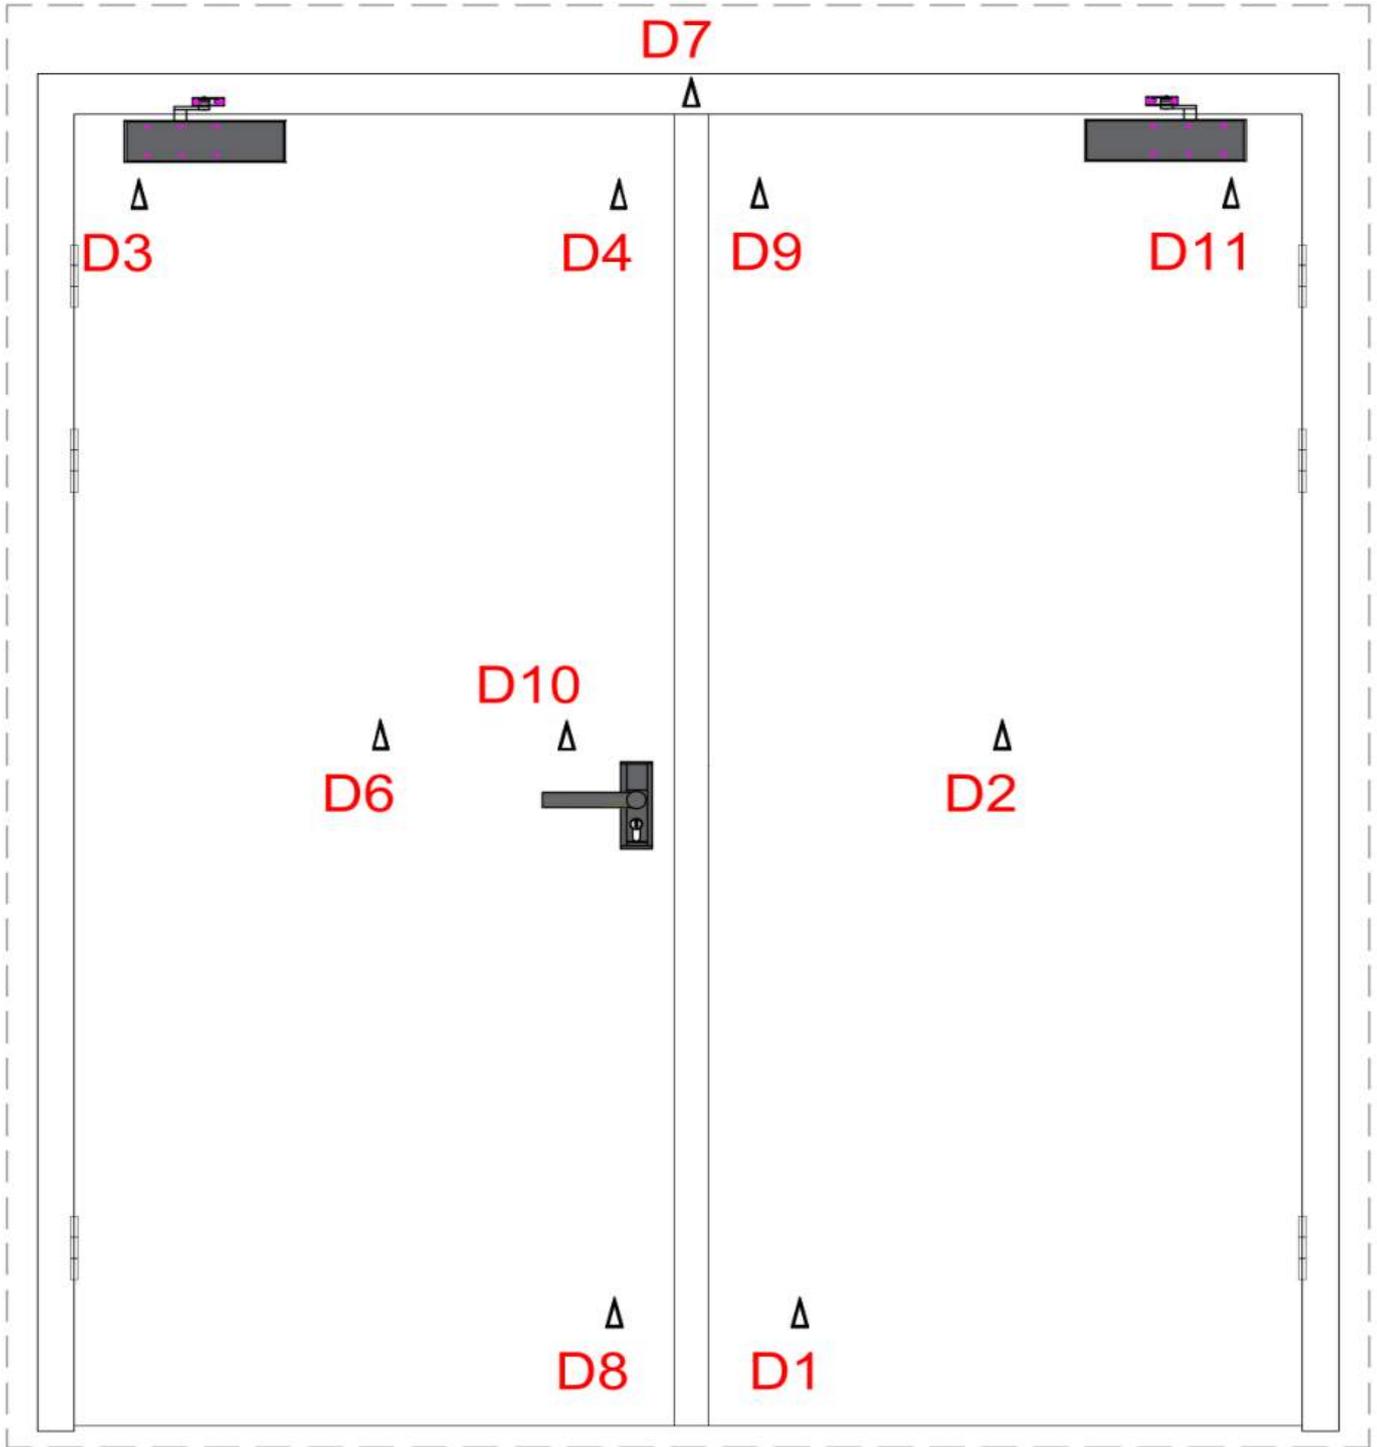
Δ: Deflection measurement points

Figure 7.3. Unexposed face deflection measurement points

Unexposed face thermocouples and deflection measurement positions are given in the Figure 7.2 and Figure 7.3. The numbering in the figure is the same as the numbering of thermocouples. Time dependent displacement values are given in the table below.

DEFLECTION	D1	D2	D3	D4	D6	D7	D8	D9	D10	D11
TIME (min)										
0	0,00	0,00	0,00	0,00	0,00	0,00	0,00	0,00	0,00	0,00
10	3,90	0,00	-14,01	-2,16	5,68	2,15	0,00	-0,35	24,46	-13,47
20	6,74	0,00	-20,48	-3,23	5,32	-2,15	6,00	-1,06	28,72	-17,02
30	7,81	0,00	-22,63	-3,23	3,19	-3,23	9,00	0,00	34,03	-18,43
40	7,45	-3,00	-25,87	-2,16	5,68	-2,15	6,00	-1,42	35,45	-23,04
50	6,39	-5,00	-23,71	-4,31	0,71	-2,15	8,00	2,84	45,02	-26,23
60	8,16	-5,00	-25,87	-5,39	1,77	-1,08	-15,00	6,03	48,21	-25,17
70	6,03	-4,00	-25,87	-3,23	5,68	-1,08	6,00	4,61	52,11	-22,33

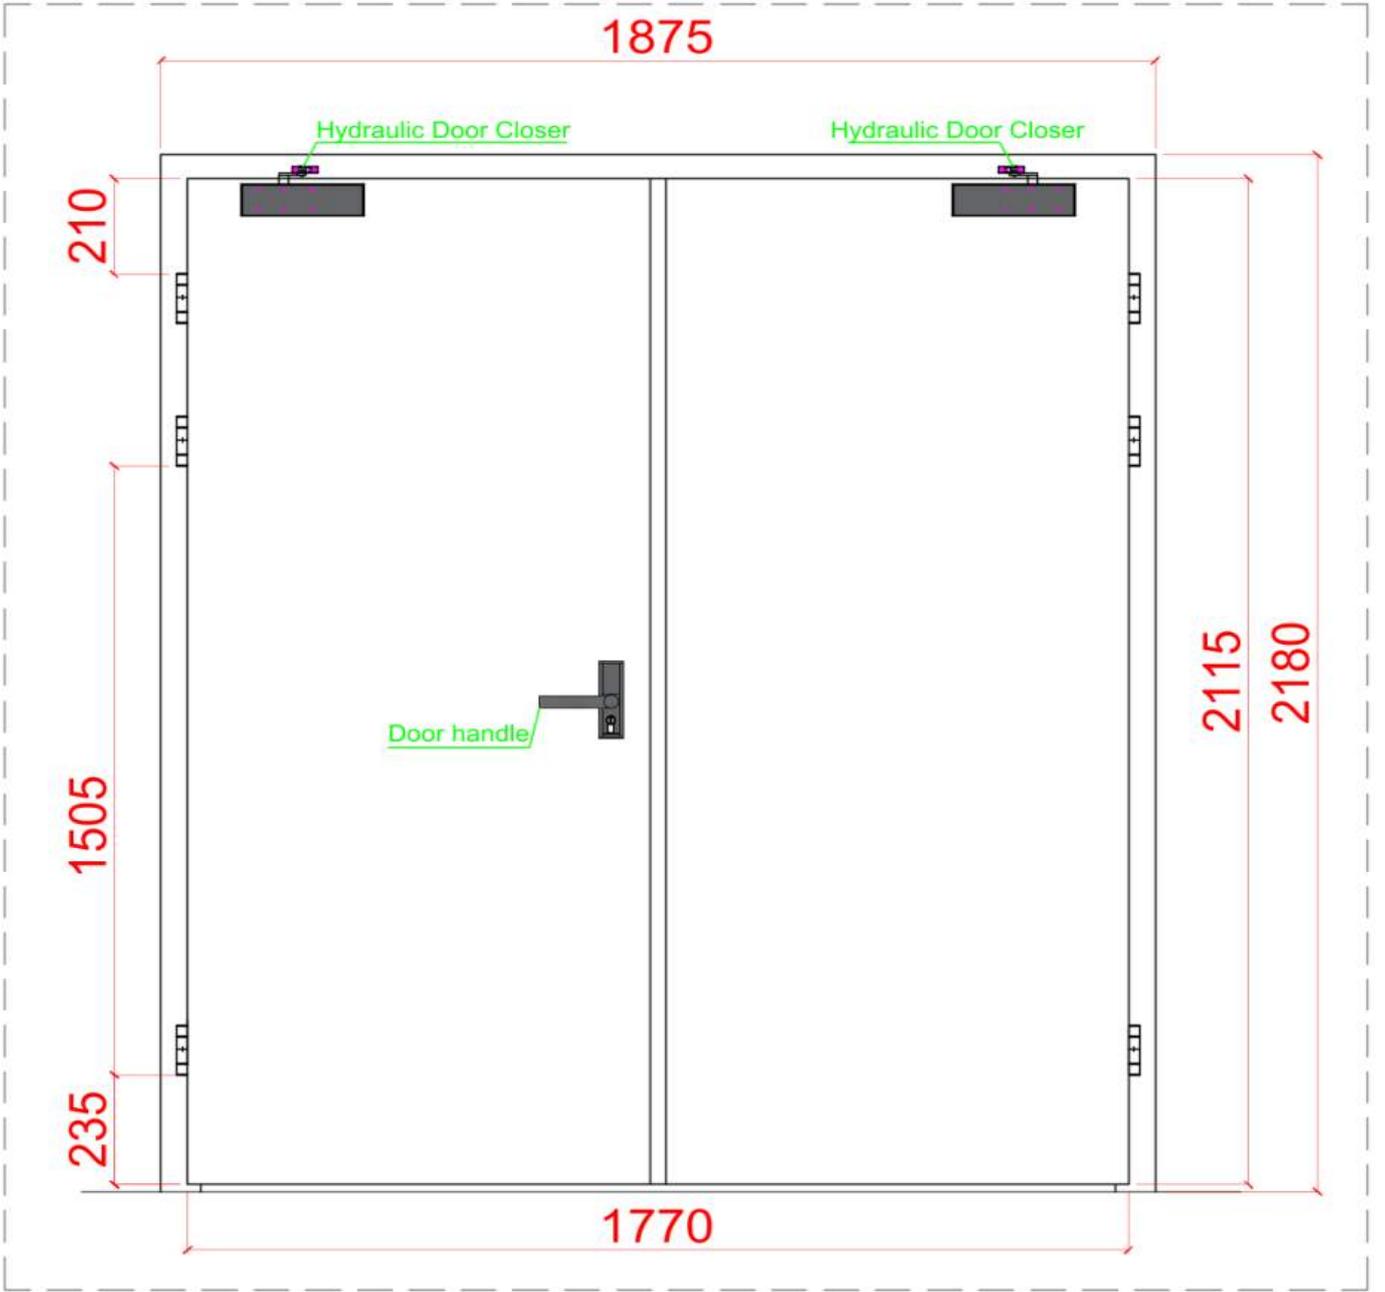
Figure 7.4.Unexposed face

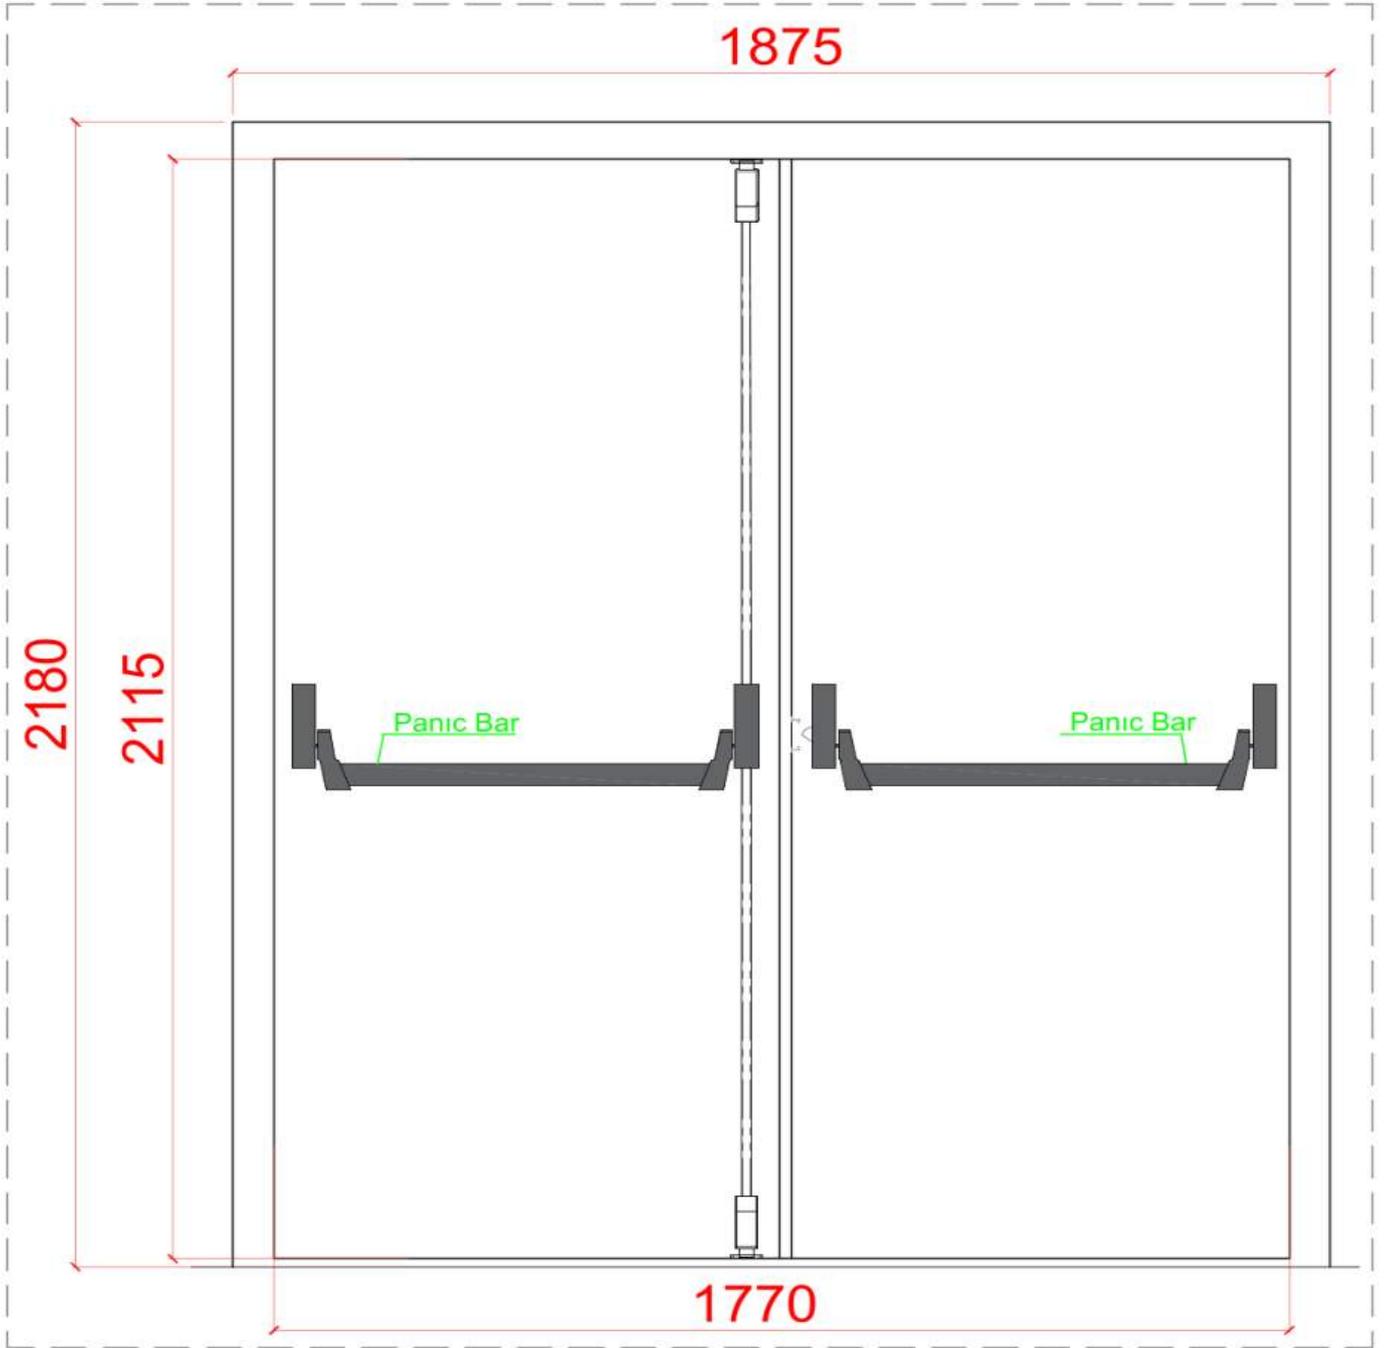
Figure 7.5.Exposed face

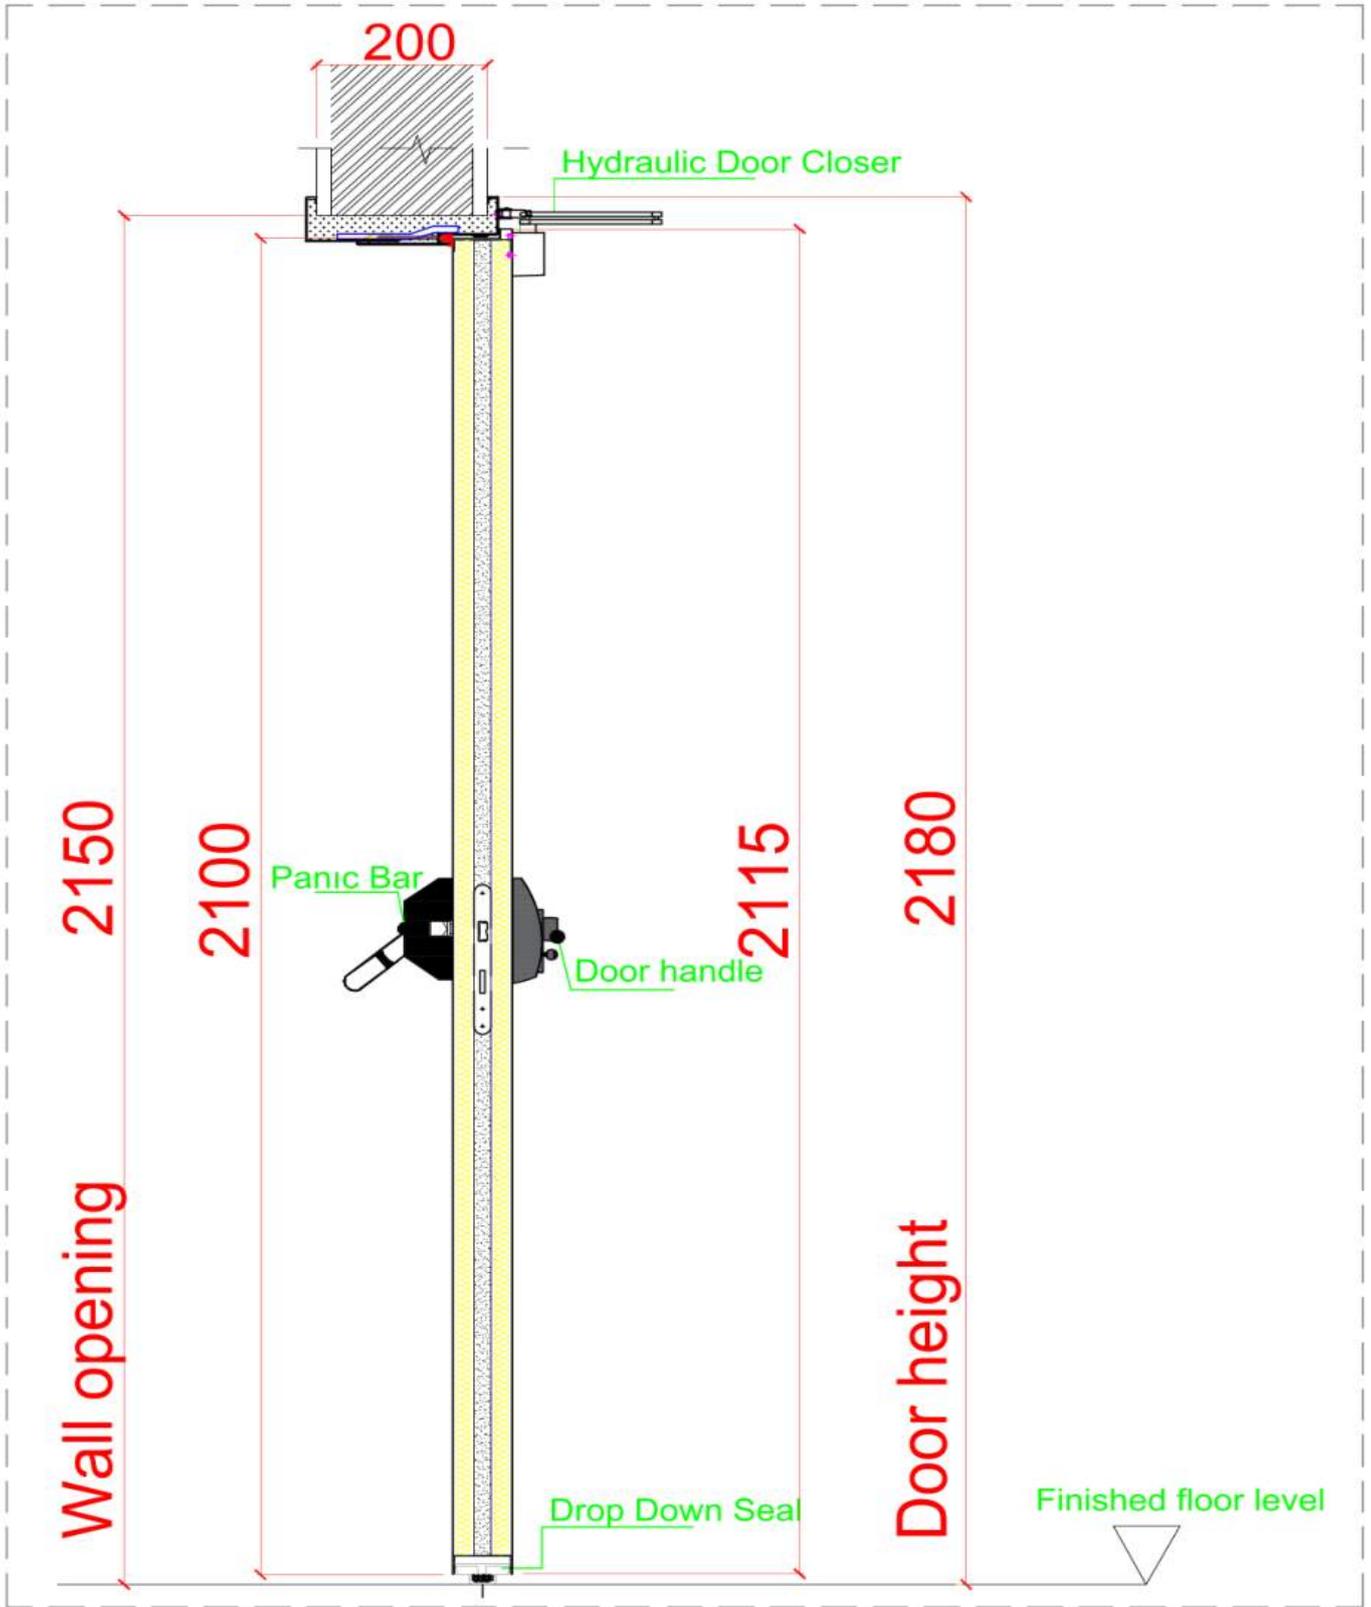
Figure 7.6.Lateral section

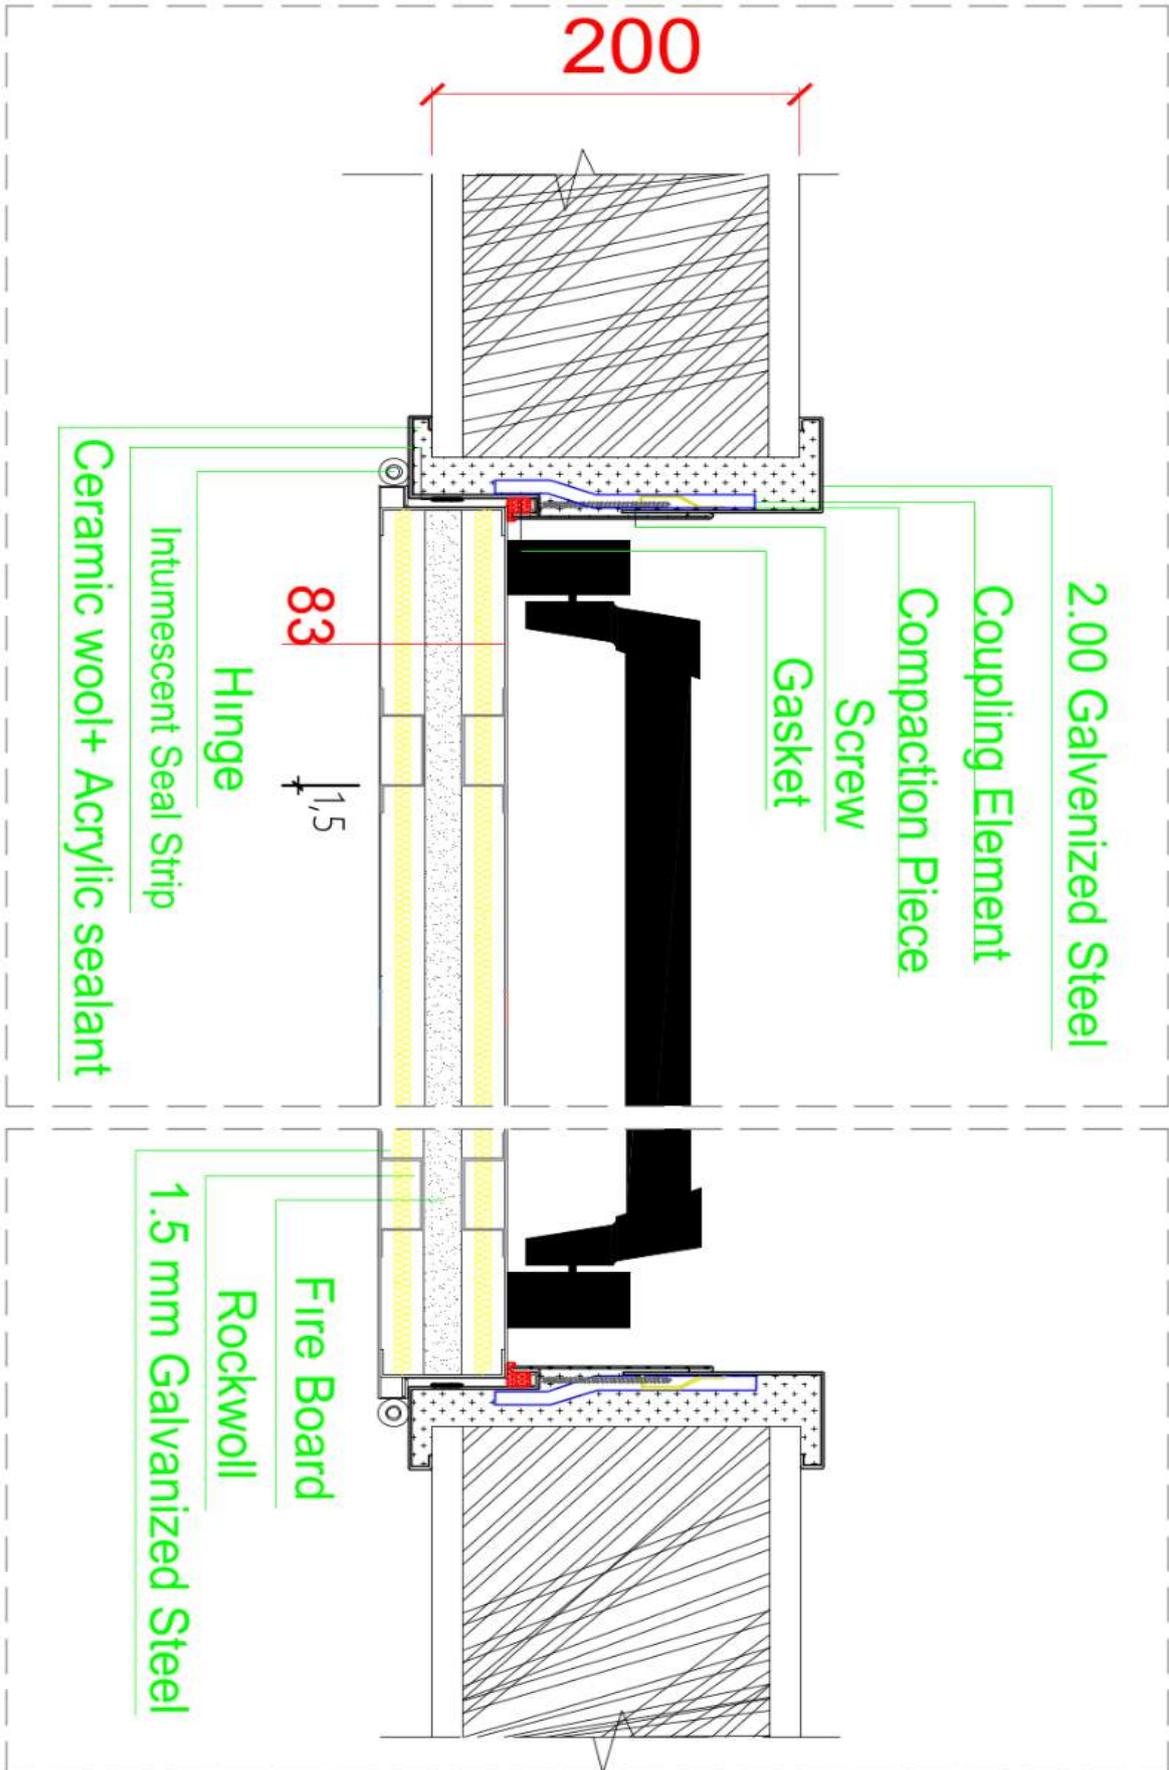
Figure 7.8. Plan section detail

-Support profiles: On both wings, an omega support profile with a thickness of 1.5 mm is installed at a distance of 200 mm from the wing edge and 275 mm from the hinge edge, in contact with both inner surfaces of the wing. The profile has long sides measuring 58 mm and a short side width of 26 mm, and extends along the full length of the wing (see Figure 7.8)

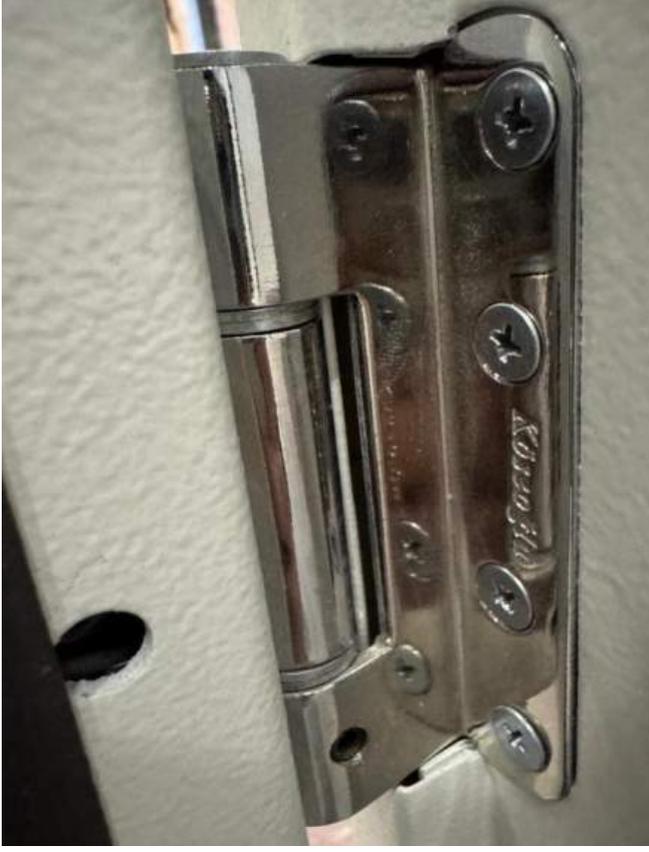
Figure 8.1.Hinge

Hinges diameter and length: 16 mm x 100 mm (Φ ,u).

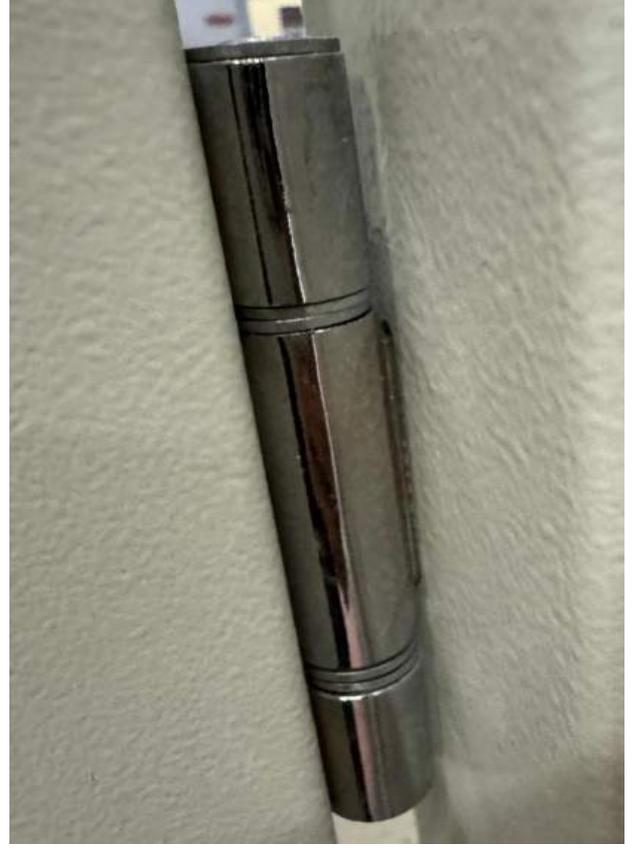
Figure 8.2.Hinge

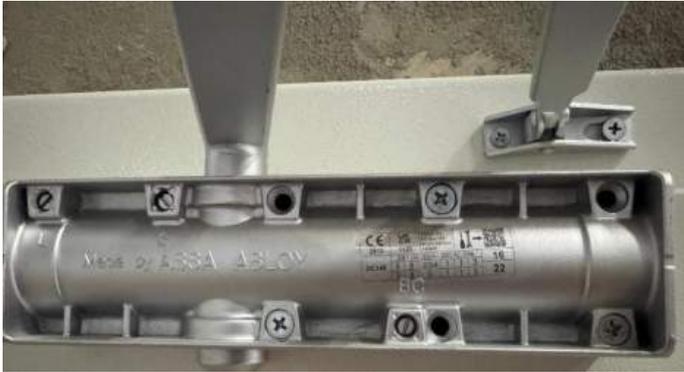
Figure 8.3.Door closer

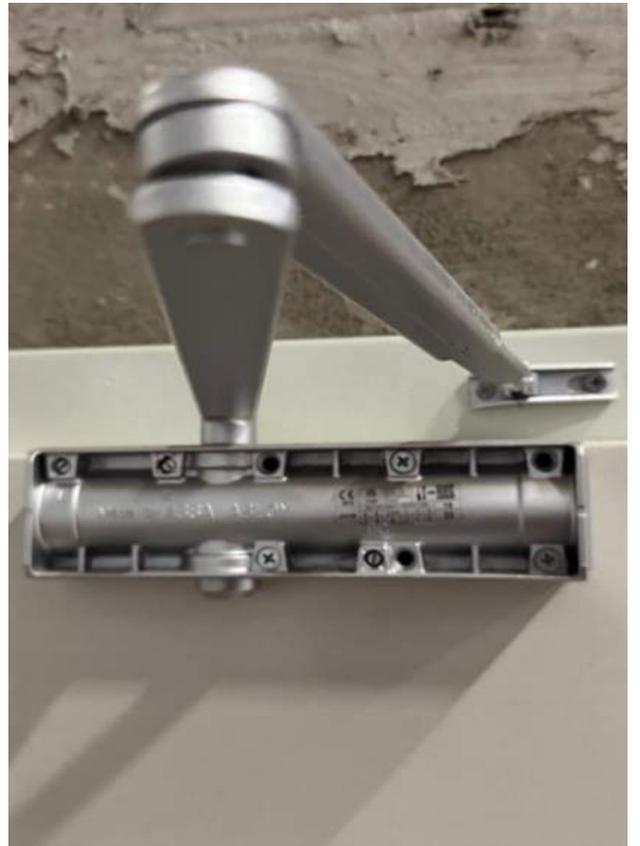
Figure 8.4.Door closer

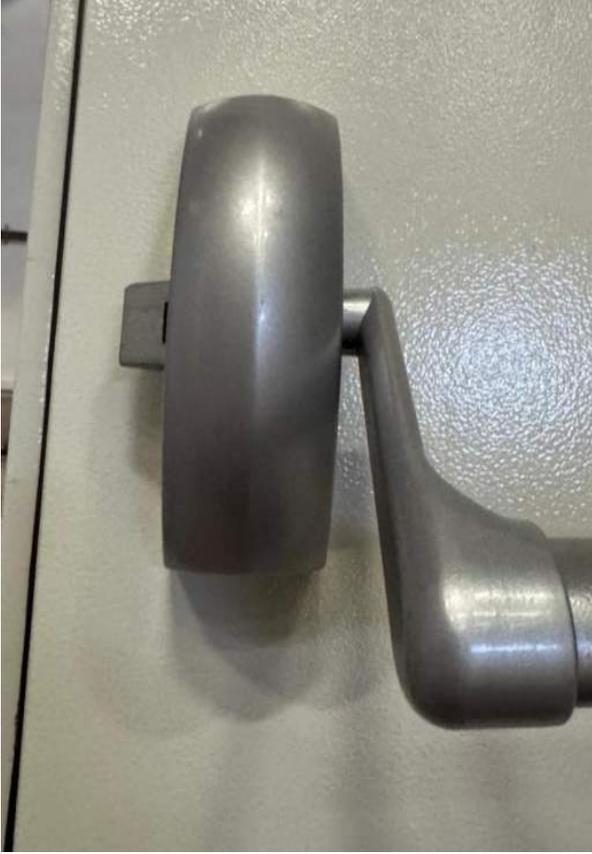
Figure 8.5.Panic bar lock

-Distance from the panic bar latch to the bottom of the leaf: 1005 mm

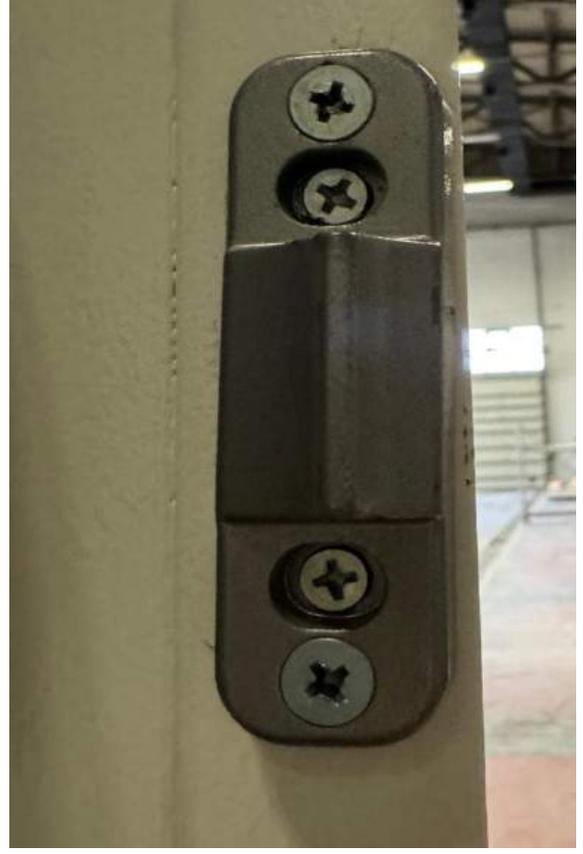
Figure 8.6.Strike plate

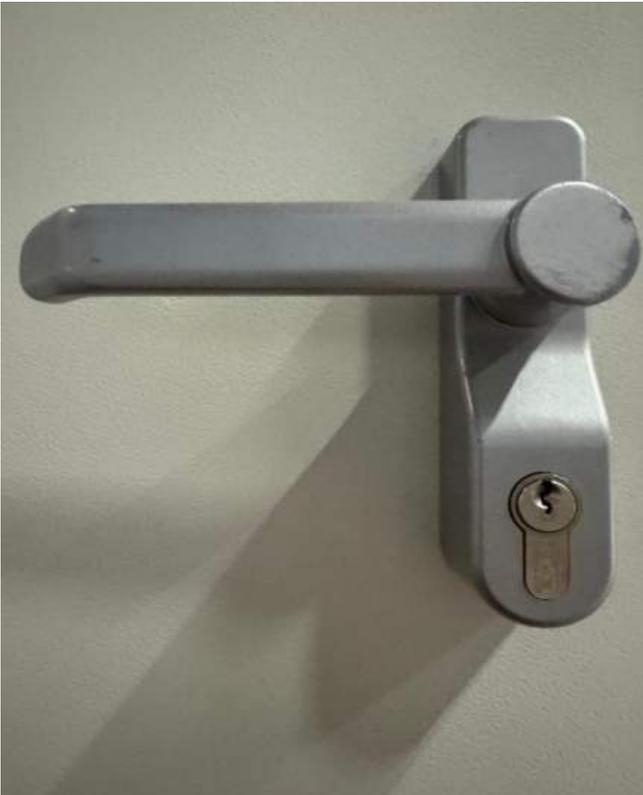
Figure 8.7.Door handle (unexposed face)

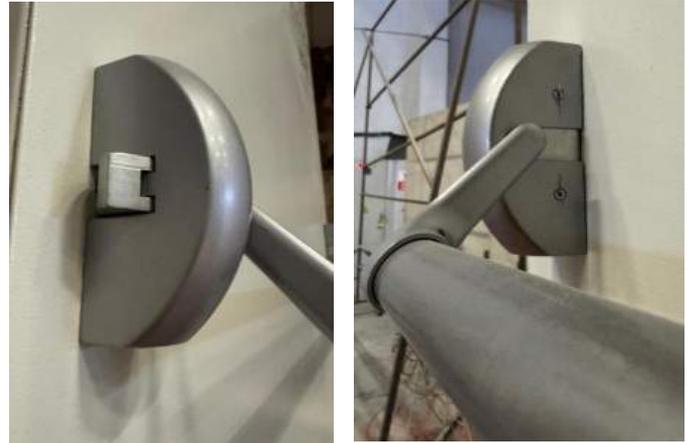
Figure 8.8.Panic bar (exposed face)

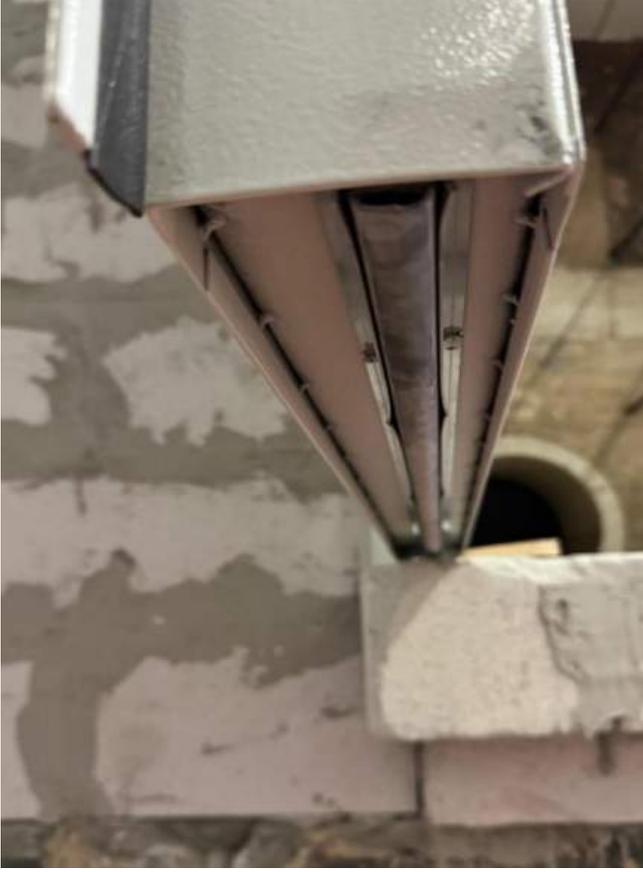
Figure 8.9.Drop seal of the active leaf

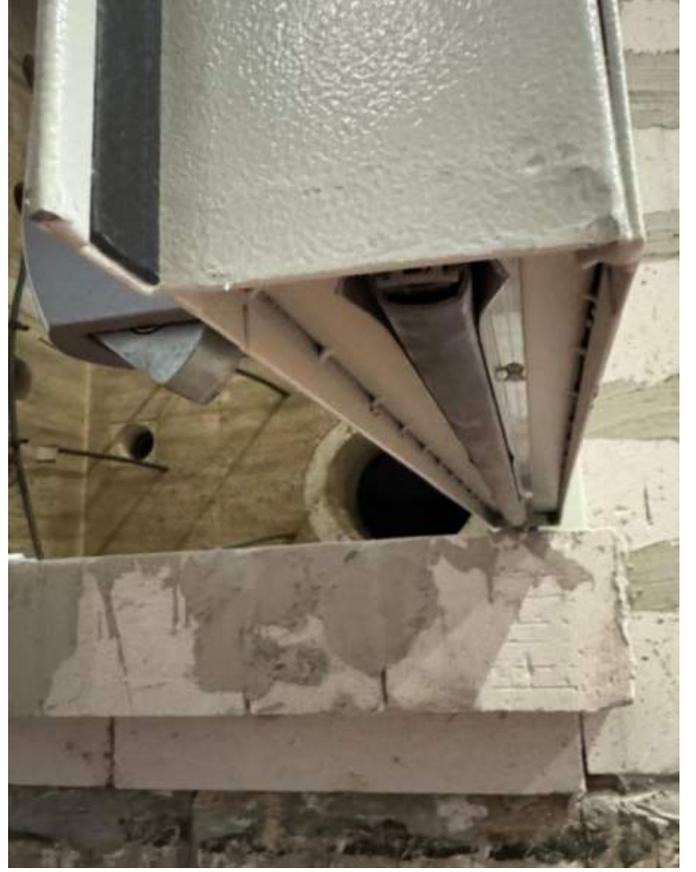
Figure 8.10.Drop seal of the passive leaf

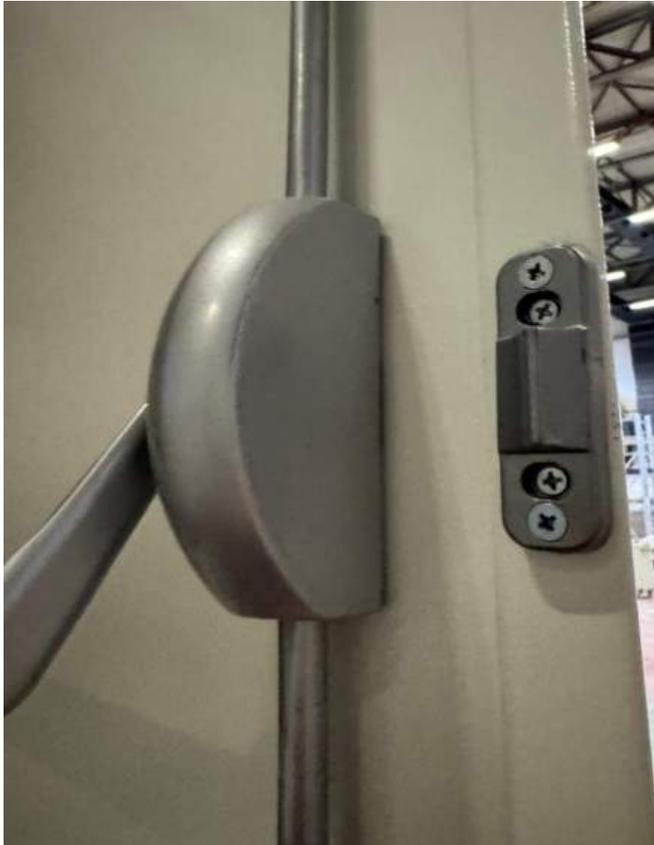
Figure 8.11.Panic bar of the passive leaf

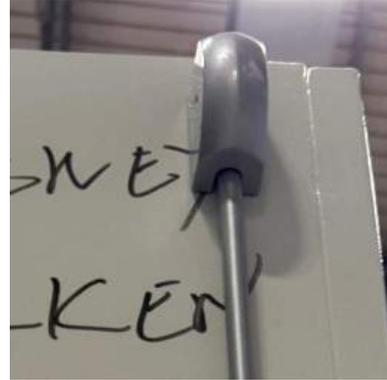
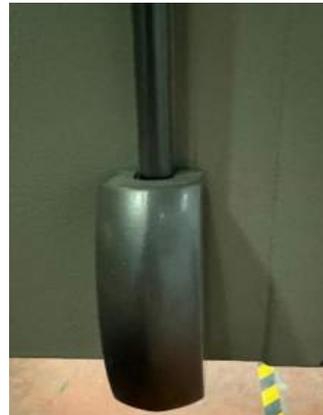
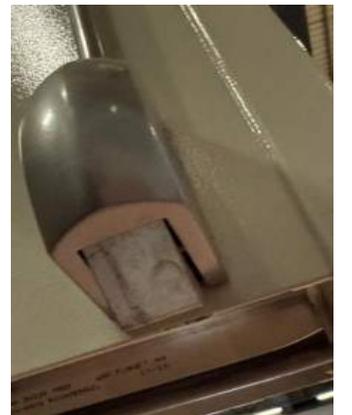
Figure 8.12.Panic bar of the passive leaf and mechanism of lock

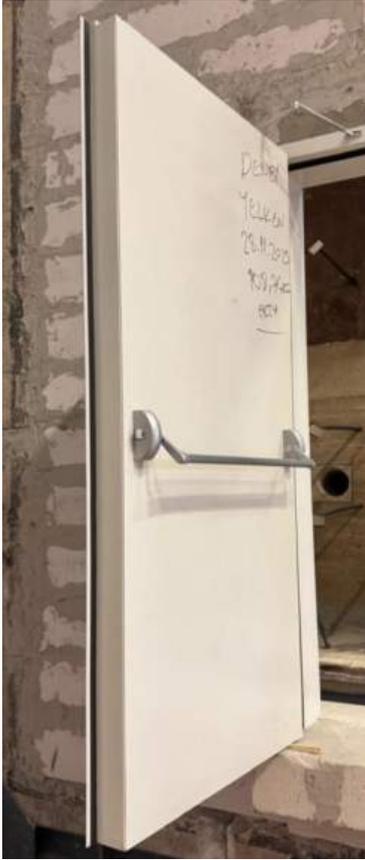
Figure 8.13. Leading edge of the active leaf

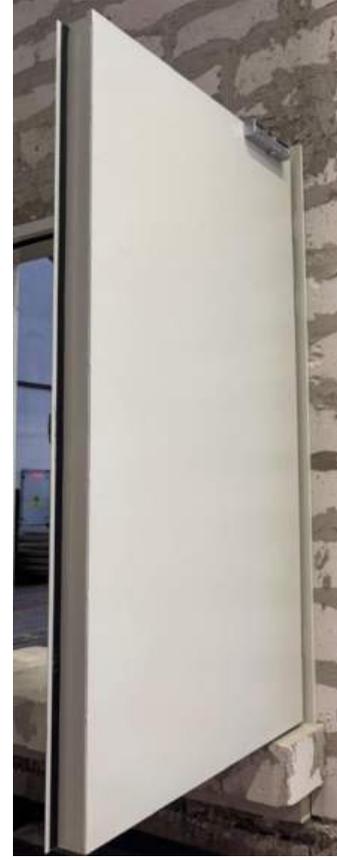
Figure 8.14. Leading edge of the passive leaf

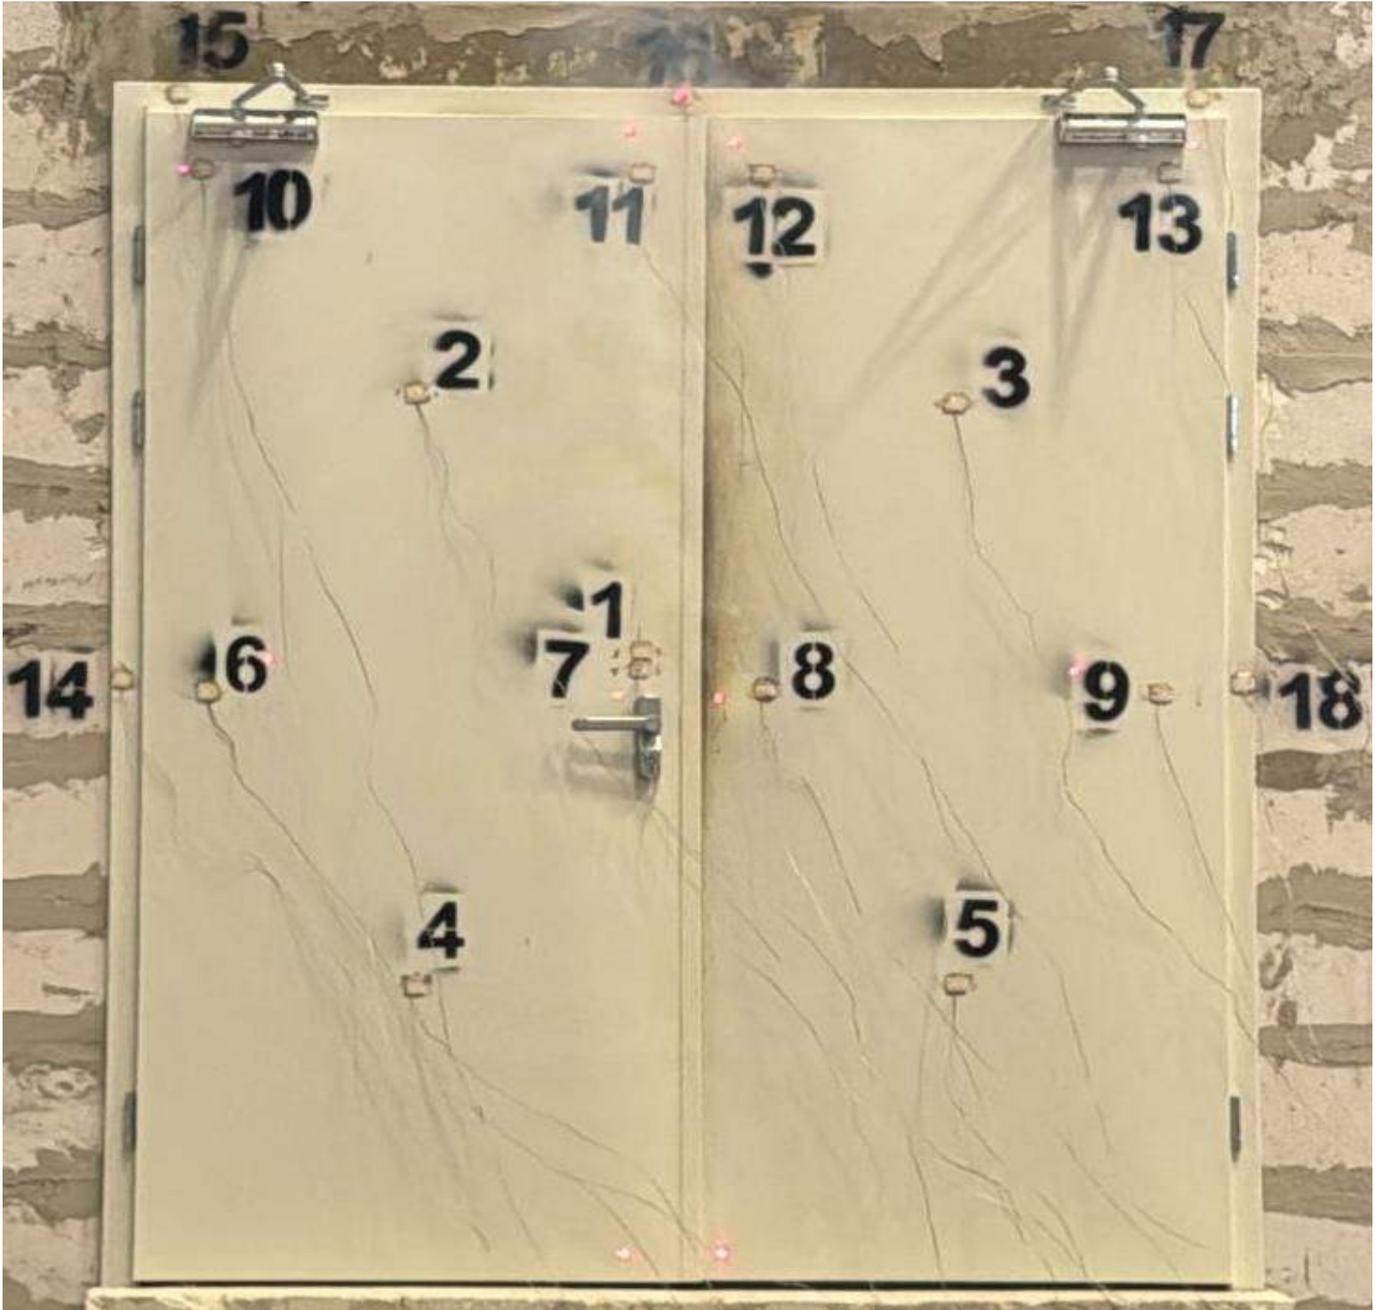
Figure 8.17. Unexposed face during test (16th minutes)

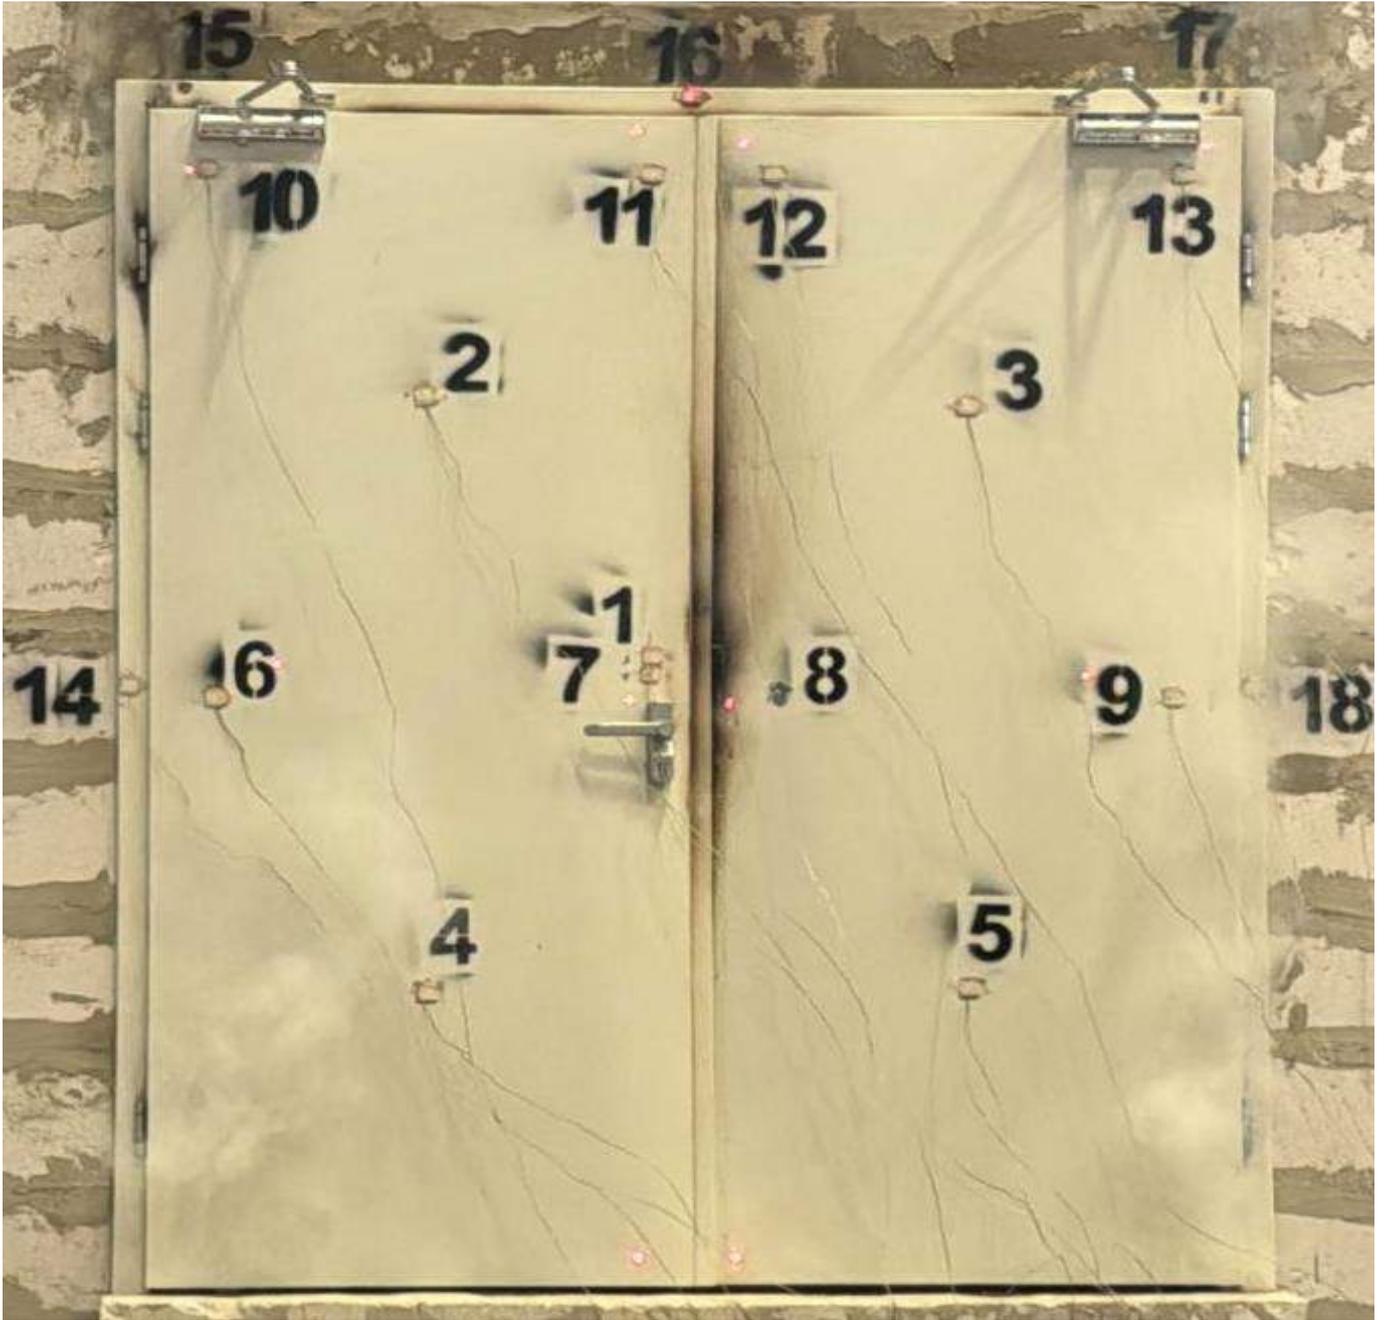
Figure 8.18. Unexposed face during test (30th minutes)

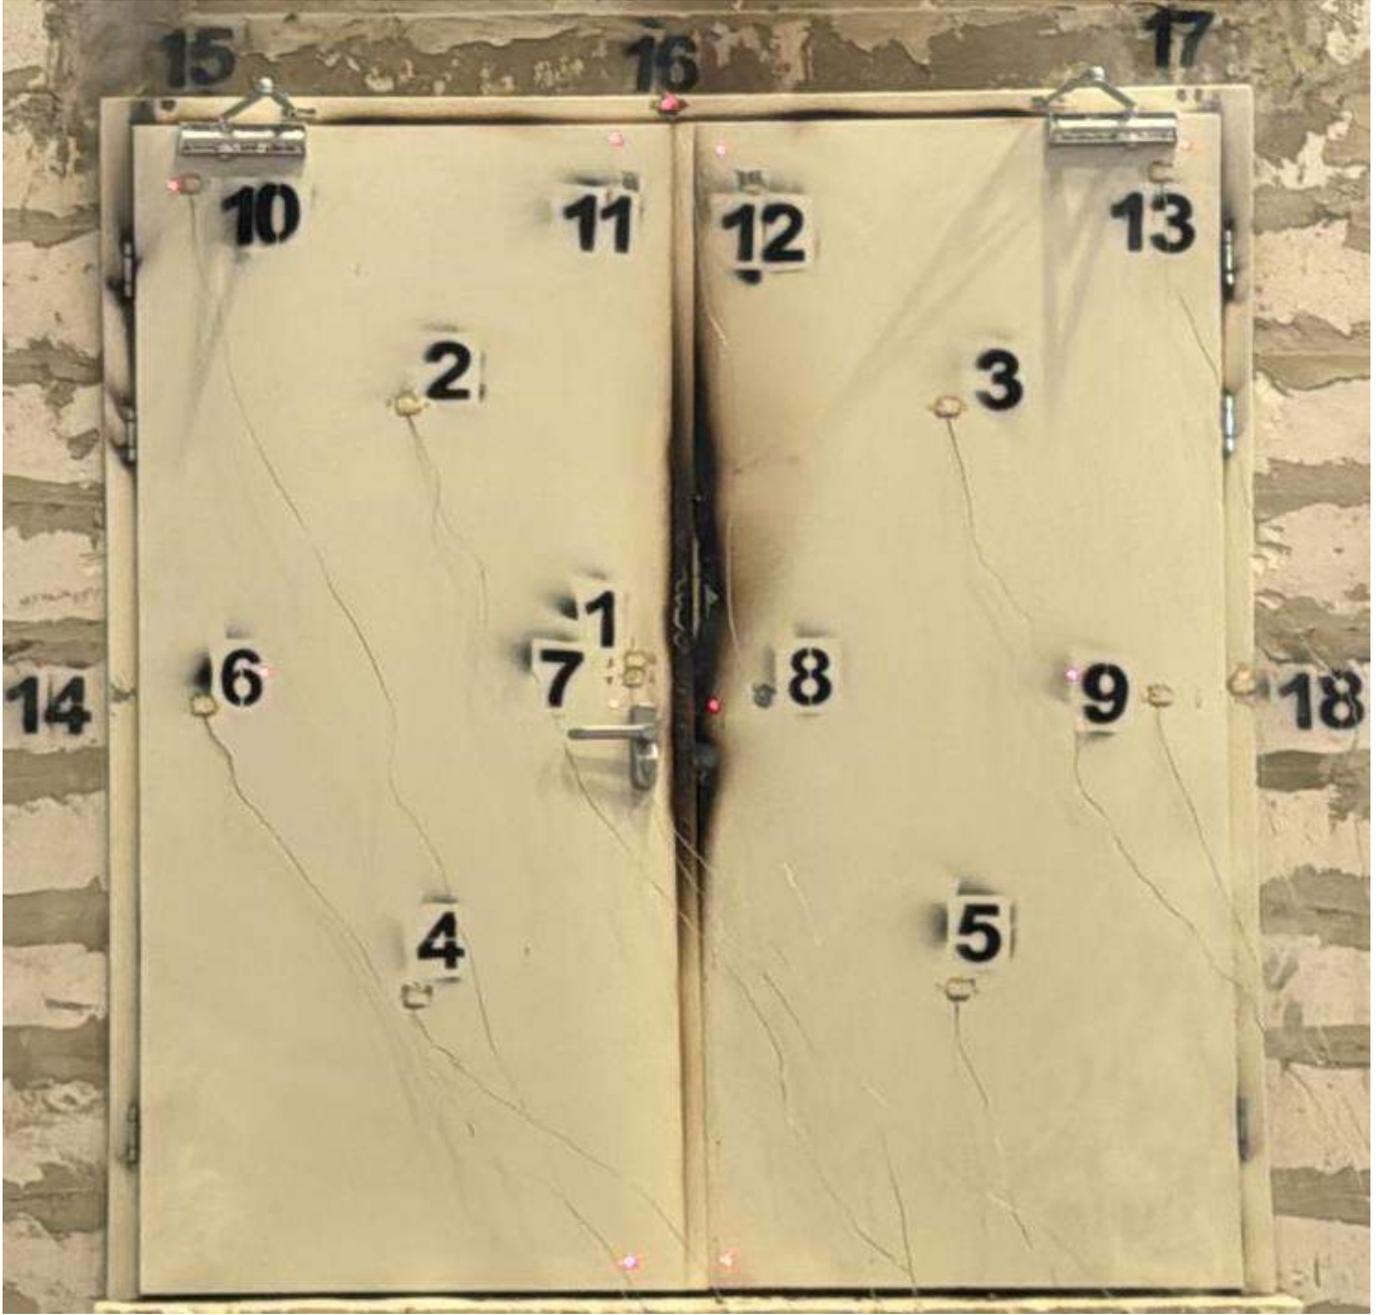
Figure 8.19. Unexposed face during test (42nd minutes)
