MUAYENE VE DENEY RAPORU
TEST REPORT

Numunenin Tanımı : 2025-366570, Double leaves fire door, -, -, -, -, 1.00, adet
(Cins, Marka, Sınıf, Tip, Tür, Model vb.)
Sample Description (Type, Mark, Class, Model etc.)

Uygulanan Standart Metot : TS EN 1634-1+A1/TS EN 1634-1+A1 Kapı ve kepenk takımları, bina hırdavatının
Applied Standard/Method açılabilir pencereleri ve elemanları için yangına dayanıklılık ve duman kontrol deneyleri - Bölüm 1: Kapı ve kepenk takımları ve açılabilir pencereler için yangına dayanıklılık deneyi

Single acting (opening away from the furnace) double leaves metal door set with metal frame test sample with " description sponsored by "YELKEN KALIP PENCERE-KAPI AKS.VE METAL SAN.TİC.A.Ş." was tested at 02 January 2026 at TSE Construction Materials Fire and Acoustics Laboratory according to TS EN 1634-1+A1:2018.

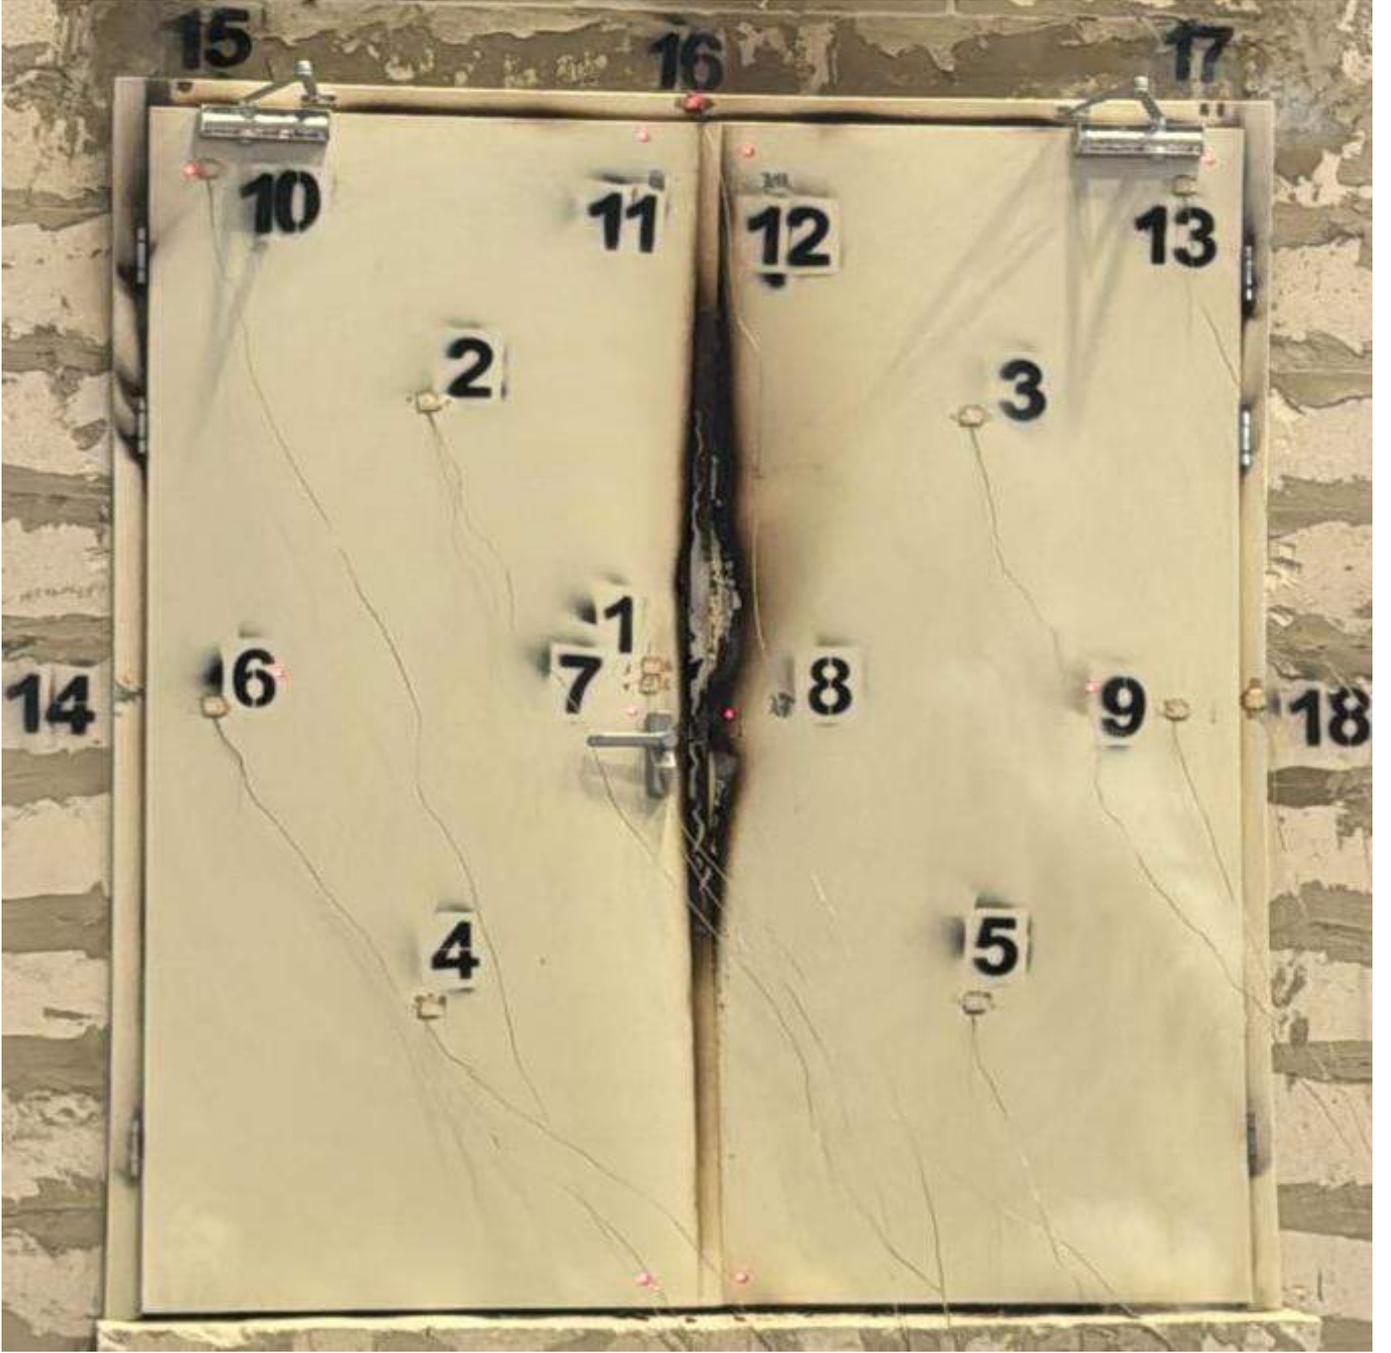
Figure 8.20. Unexposed face during test (52nd minutes)

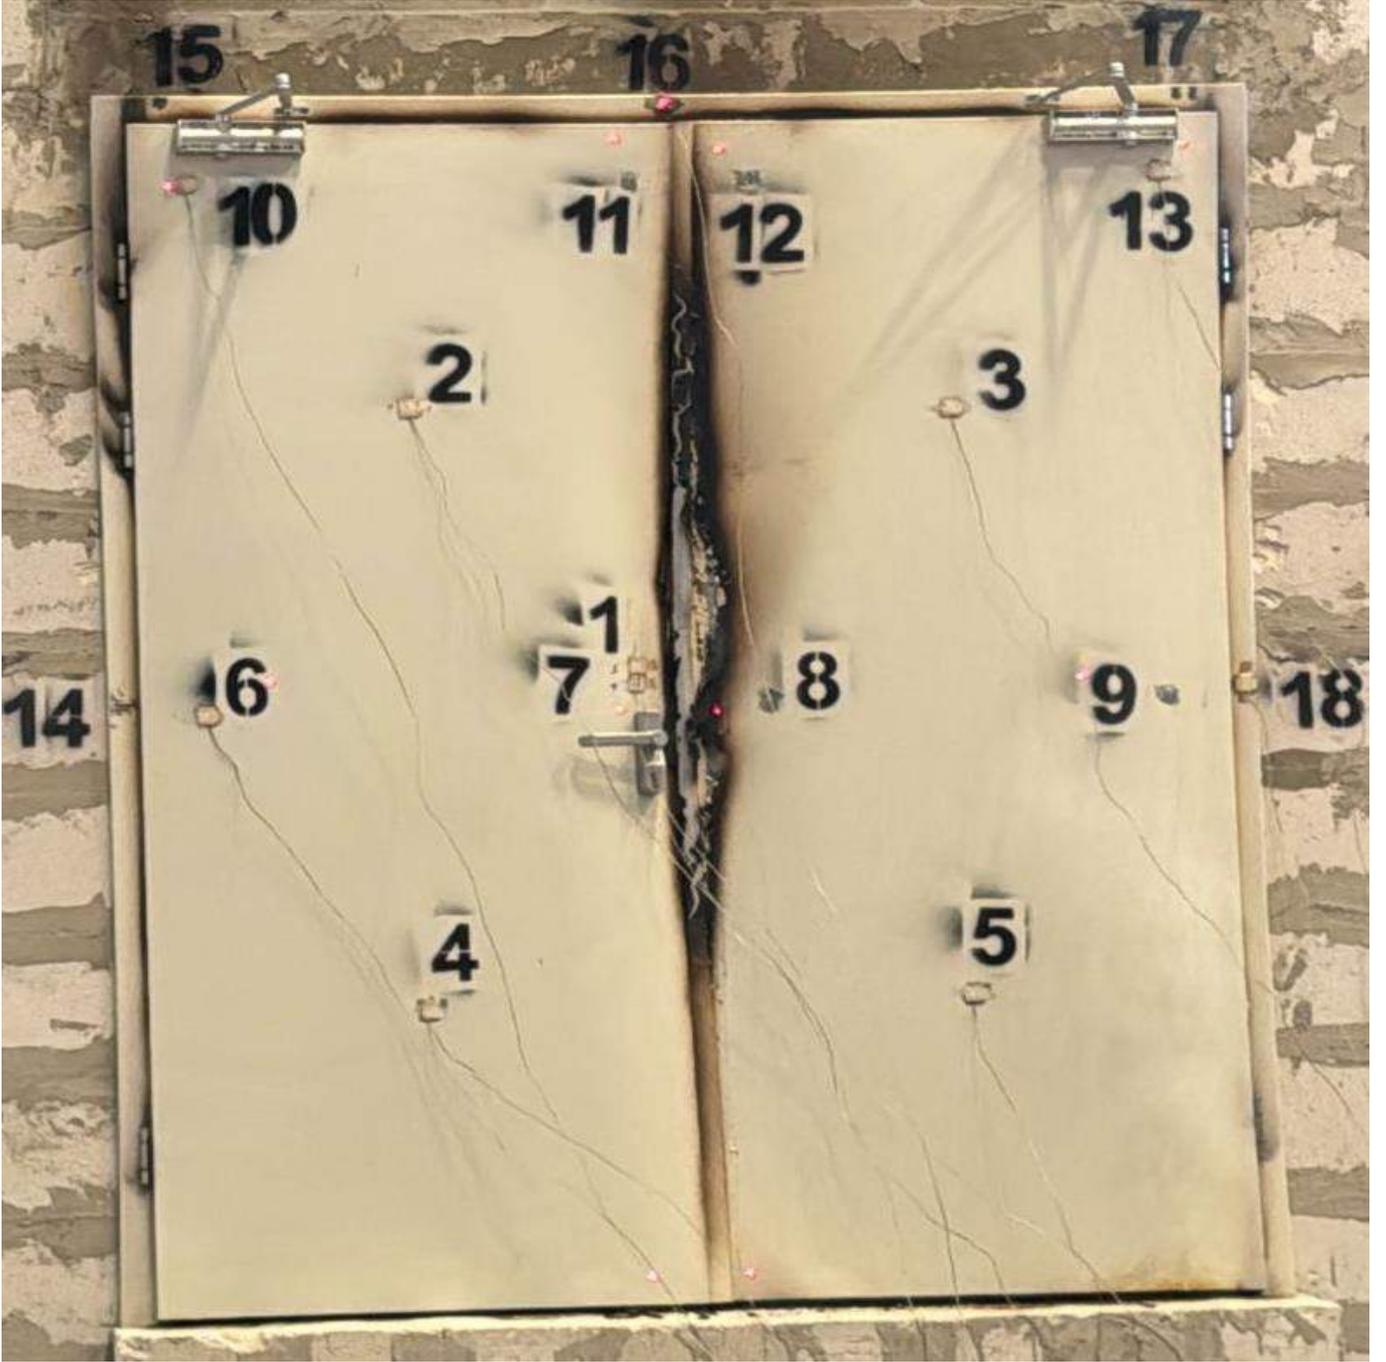
Figure 8.21. Unexposed face during test (60th minutes)

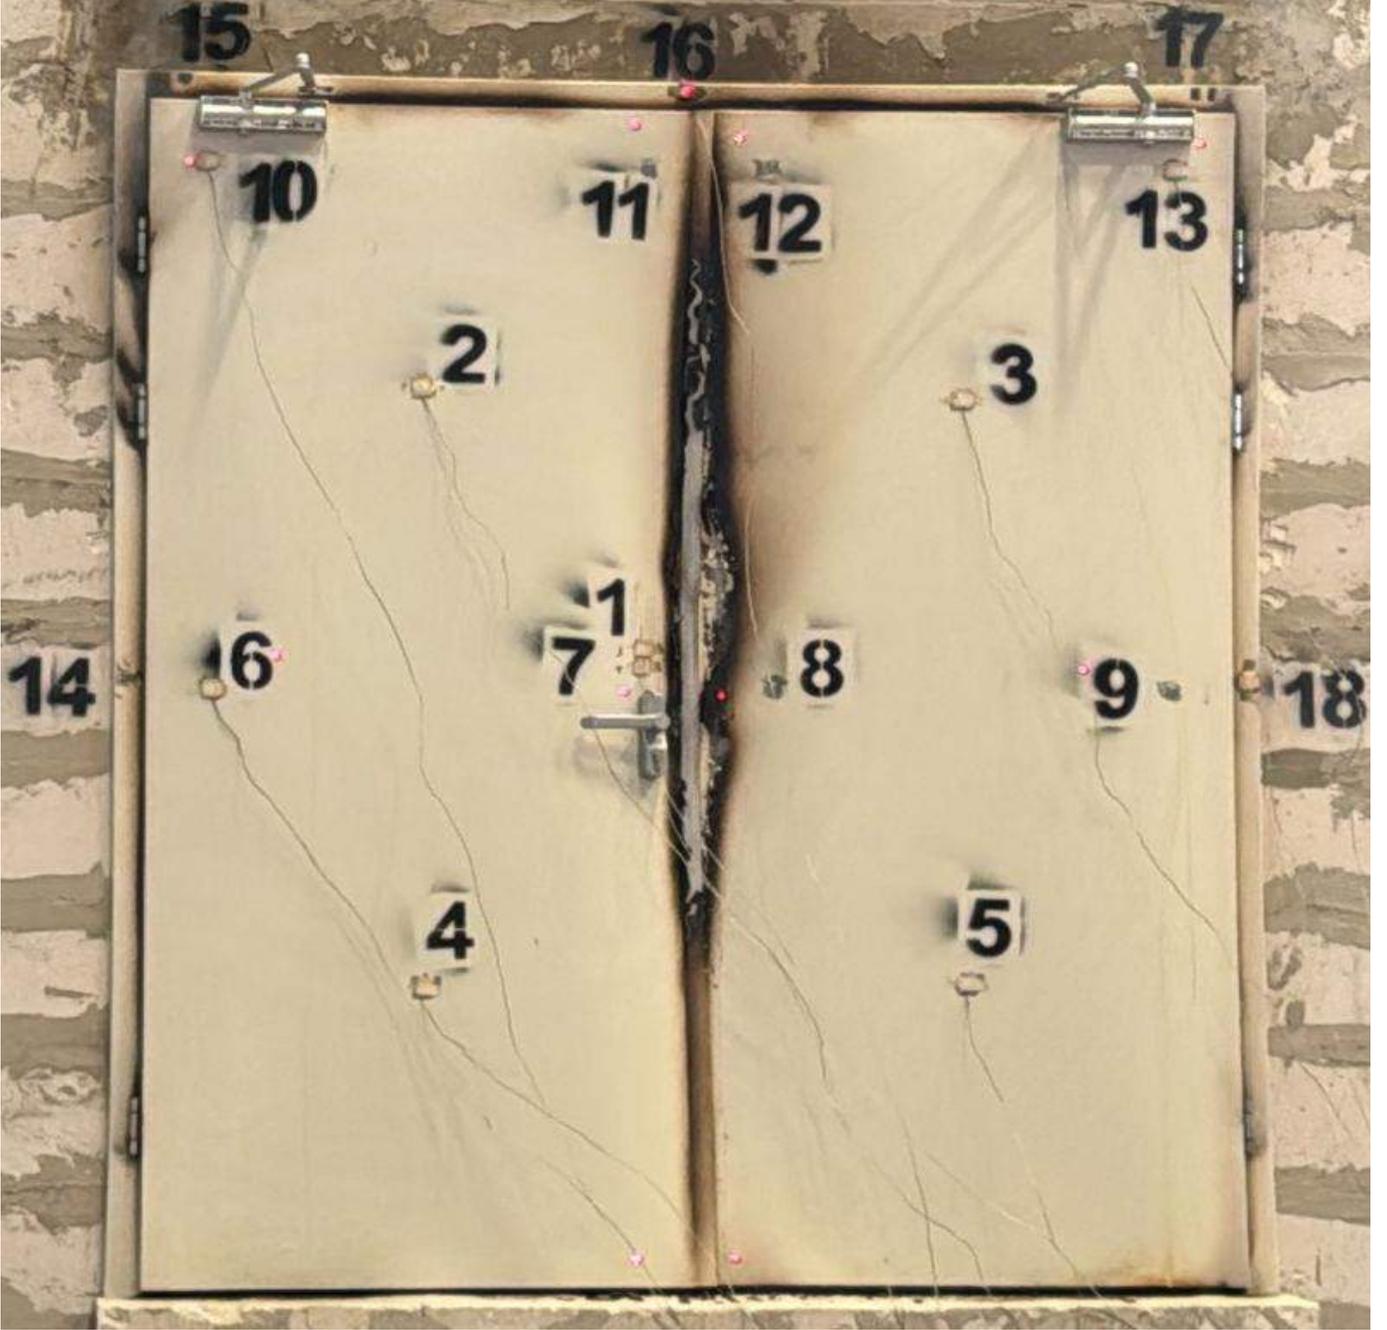
Figure 8.22. Unexposed face during test (68th minutes)

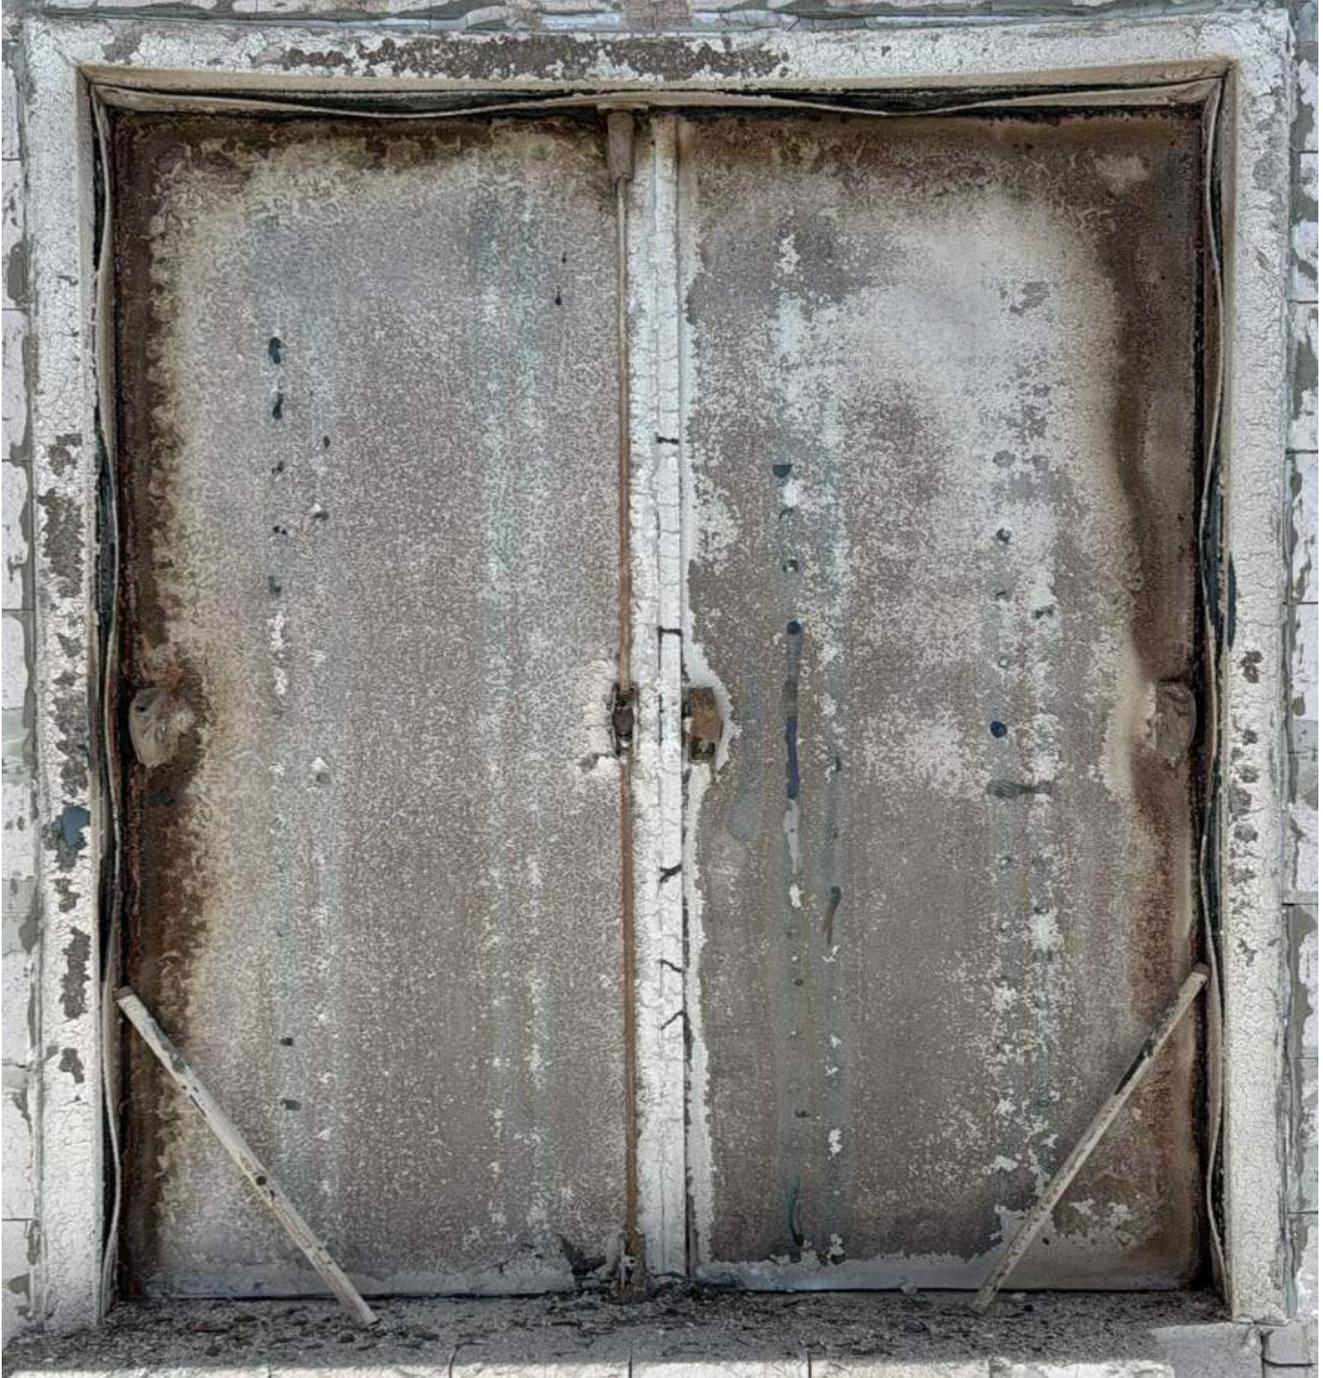
Figure 8.23. Exposed face after test

71.50	Sustained flaming observed on right of the down edge between passive leaf and sill. (more than 10 seconds) Integrity failure.
75.01	Test terminated.
